The Use of the Silva-Lambe-Marr Method for Estimating the Annual Probability of Failure of the Tailings Dams at the Copper Mountain Mine, British Columbia, Canada

Steven H. Emerman, Ph.D., Malach Consulting, LLC, 785 N 200 W, Spanish Fork, Utah 84660, USA, Tel: 1-801-921-1228, E-mail: SHEmerman@gmail.com

Report prepared for Confederated Tribes of the Colville Reservation, submitted July 1, 2022

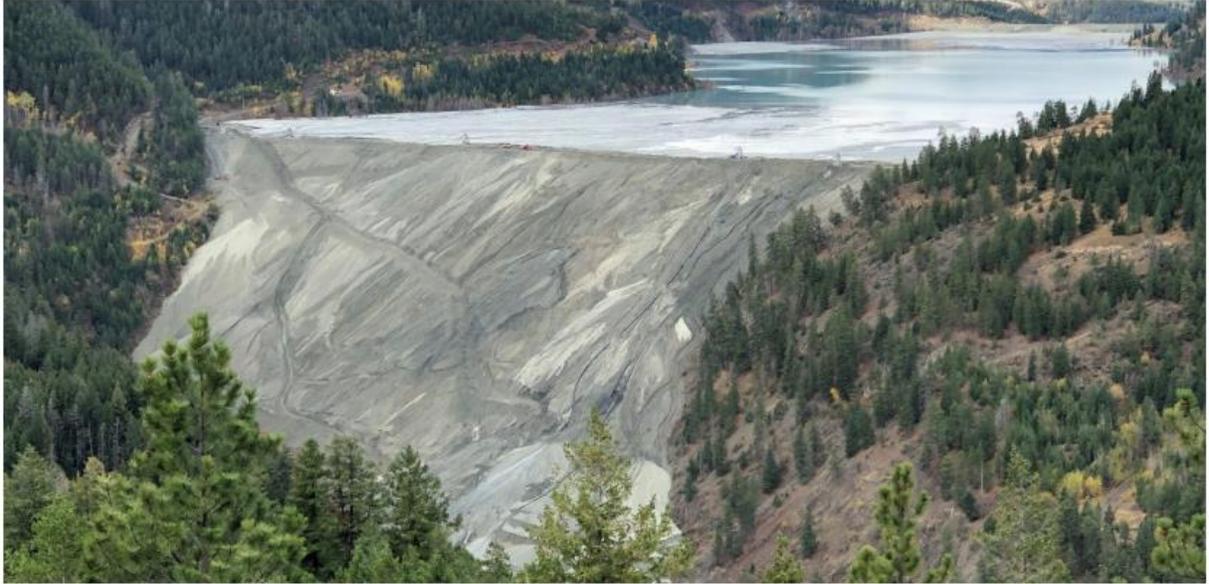
Photo II-1 East Dam downstream slope looking west from the Copper Mountain Road (October 14, 2020)

Figure 3a. At the end of 2022, the crest of the East Dam will be 973 meters above sea level, corresponding to an approximate height of 172.5 meters. The permitted crest elevation of 997 meters above sea level (corresponding to an approximate height of 196.5 meters) will be achieved in 2027. Photo from Klohn Crippen Berger (2021).

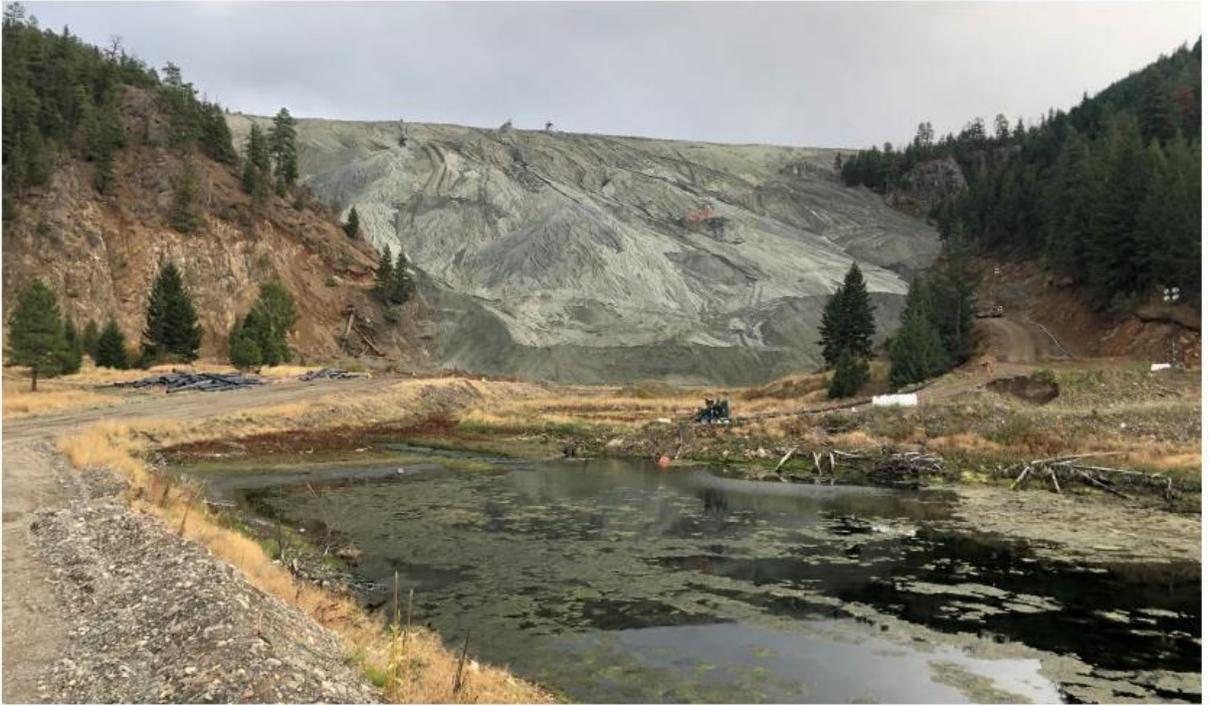
Photo II-26 West Dam downstream slope looking east from toe seepage pond (October 14, 2020)

Figure 3b. At the end of 2022, the crest of the West Dam will be 973 meters above sea level, corresponding to an approximate height of 164.5 meters. The permitted crest elevation of 997 meters above sea level (corresponding to an approximate height of 188.5 meters) will be achieved in 2027. Photo from Klohn Crippen Berger (2021).

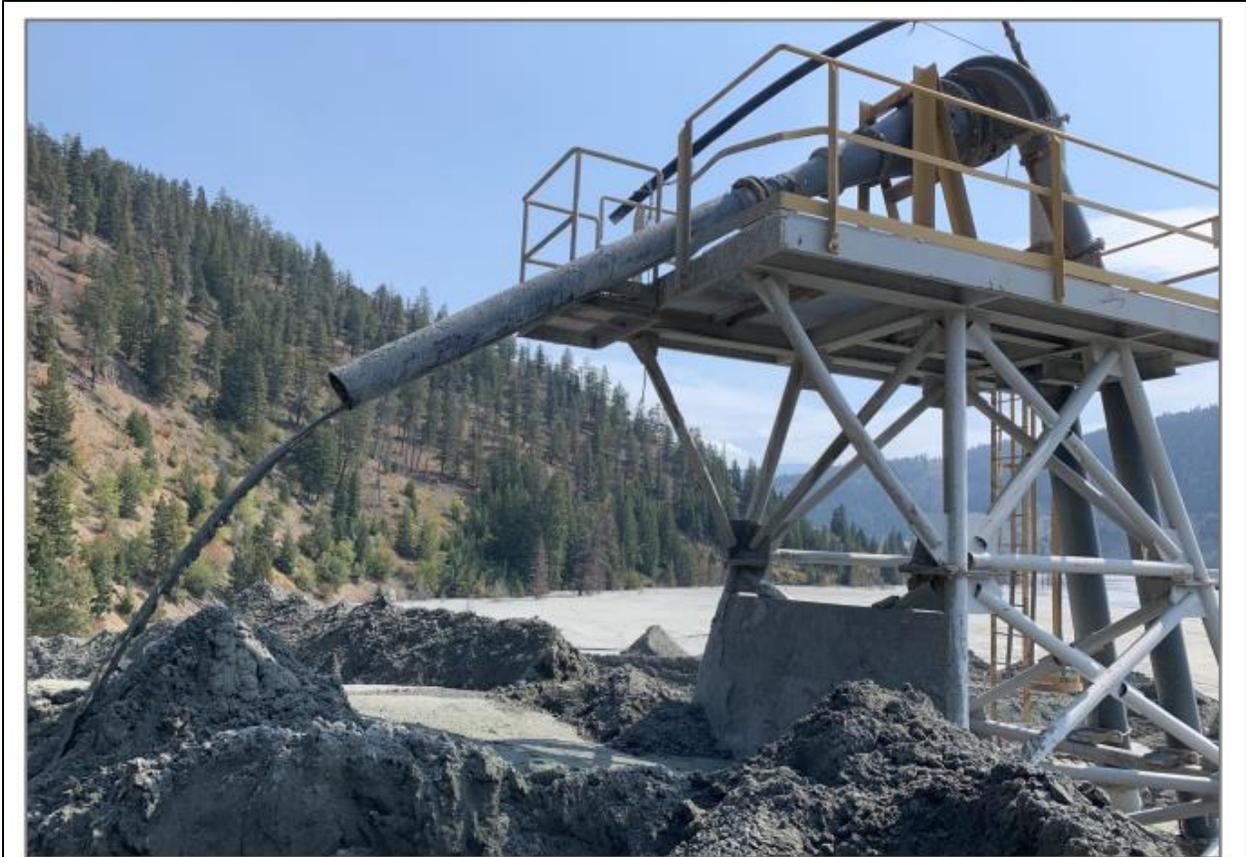
Photo 16: Cyclone discharging underflow (cyclone sand) on downstream face of West Dam

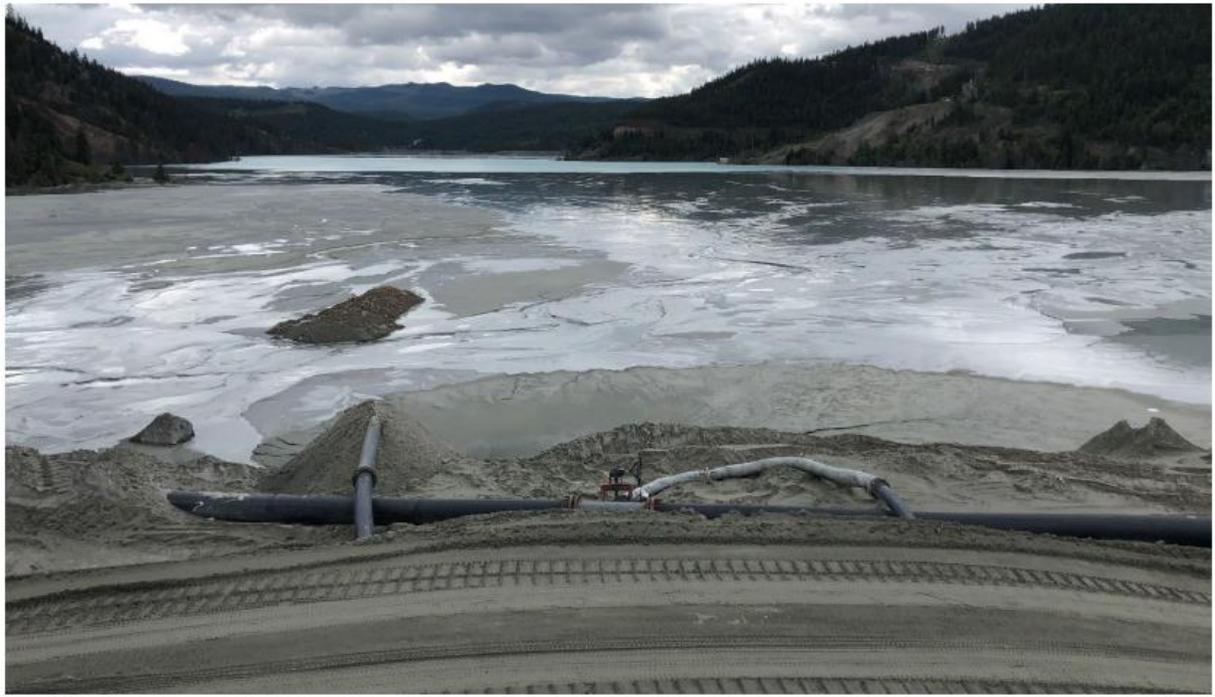
Figure 17a. The overflow from the cyclones (see Fig. 16) consisting of finer tailings and water is discharged from the crest of the West Dam toward the interior of the tailings management facility. The coarser fraction of the overflow settles closer to the dam crest to form a tailings beach (foreground of photo; compare with Figs. 2 and 11). The finest fraction of the overflow (slimes) is carried to the interior of the tailings management facility (background of photo; compare with Figs. 2 and 11). Photo from Tetra Tech (2022).

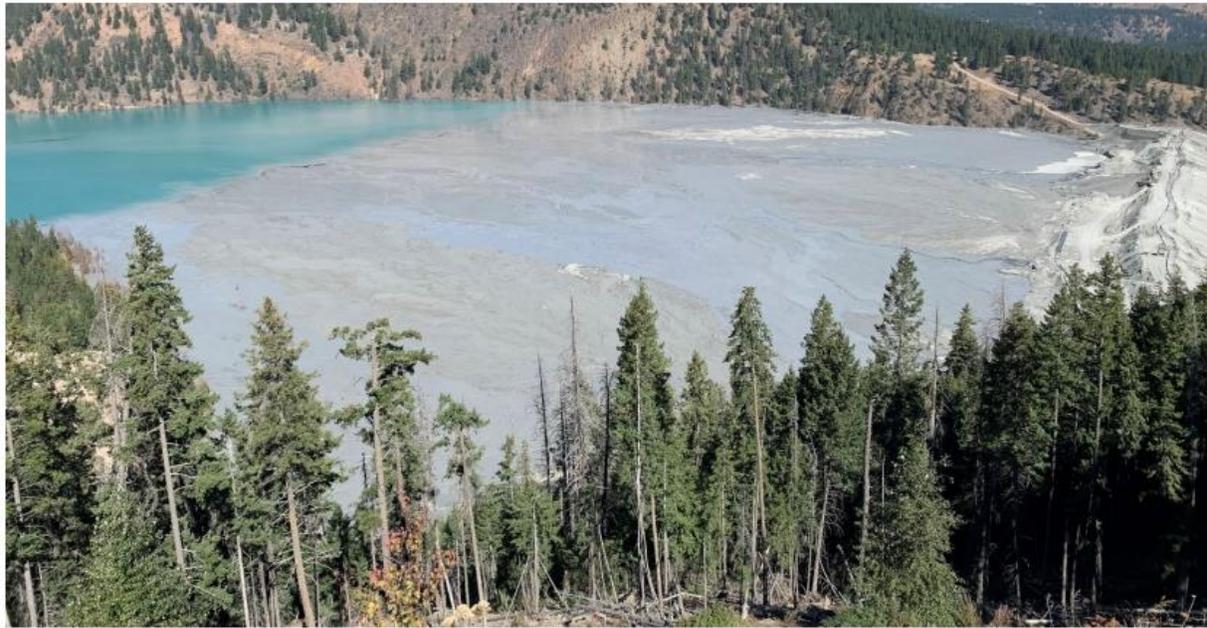
Figure 17b. The overflow from the cyclones (see Fig. 16) consisting of finer tailings and water is discharged from the crest of the East Dam toward the interior of the tailings management facility. The coarser fraction of the overflow settles closer to the dam crest to form a tailings beach (middle to right-hand side of photo; compare with Figs. 2 and 11). The finest fraction of the overflow (slimes) is carried to the interior of the tailings management facility (left-hand side of photo; compare with Figs. 2 and 11). Photo from Tetra Tech (2022).

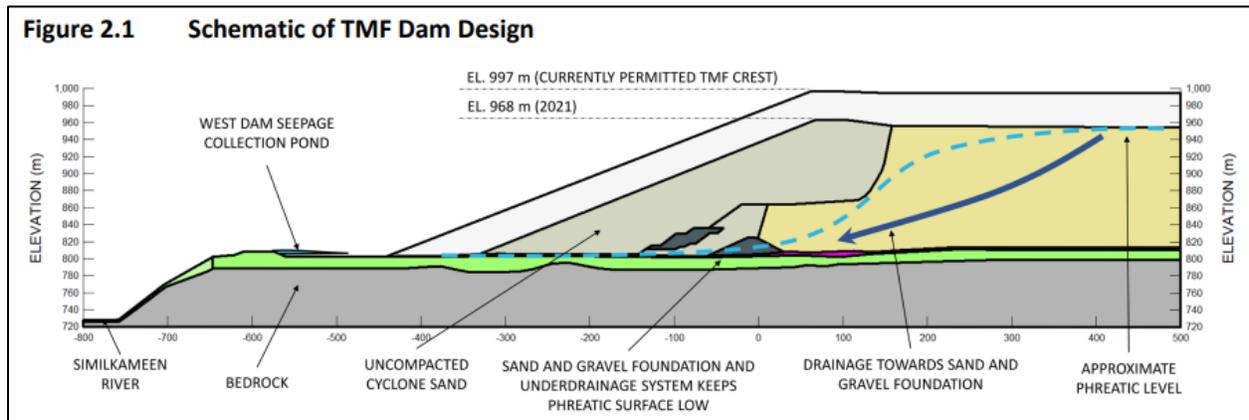
Figure 18. The cross-section of the West Dam clarifies that, despite the use of the term “modified centerline,” the tailings dams at the Copper Mountain mine are constructed using the upstream method, in that the dikes (uncompacted cycloned sand) are constructed on top of the uncompacted, fine-grained tailings (tan color) that they are impounding (compare with Figs. 12a, 13 and 14). The upstream construction method is the cheapest because it requires the least amount of construction material (compare Figs. 12a-c). The method is also the most dangerous because, if the underlying tailings liquefy, the dikes can fail by falling into or sliding over the liquefied tailings even if the dikes temporarily maintain their structural integrity. The upstream construction method is prohibited in Brazil, Chile, Ecuador and Peru. Figure from Klohn Crippen Berger (2022a).

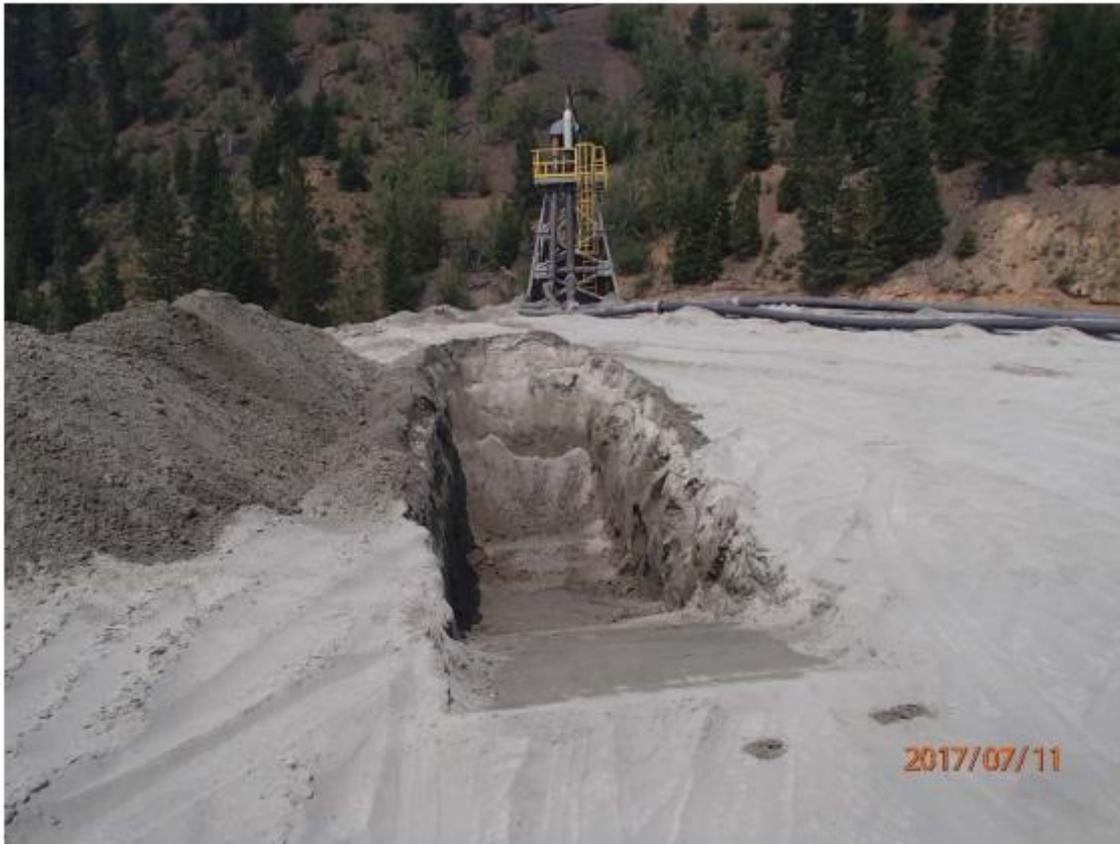
Figure 20a. The as-built reports by AMEC (2016a) and Klohn Crippen Berger (2017b, 2018, 2019) document extensive testing of construction material. However, as the above photo of a test pit indicates, this testing was carried out only on the material (uncompacted cycloned sand) that had been used to raise the tailings dams since the previous annual report. By contrast, there is essentially no documentation of any testing that occurred prior to 2015. Tetra Tech (2022) described the construction material for the starter dams (constructed in 1971) as “random” and stated that “there is limited data on the compacted cycloned sands that were used to construct the dam shell prior to 1980.” In fact, prior to 2015, it does not appear that construction was even carried out in accordance with the design. According to Tetra Tech (2022), “The reactivation design also called for a rockfill zone at the toe of the dams, extending back to the pre-2011 dam slope and 40 to 50 m above the dam toe. However, there is no indication that this was ever built; based on as-built records (KCB 2021b) [Klohn Crippen Berger (2021) in this report], the zone where rockfill was proposed to be used was constructed of cyclone sand ... The reactivation design also called for slope drains, similar in design to the 2014 crest drain (AMEC 2011), to be laid along the downstream slopes of the dams, but there is no evidence that these were installed.” Based on the contrast between the current quality of testing and the pre-2015 testing, as well as the extensive construction that occurred prior to 2015, the category for Level of Engineering in the area of Design – Testing was chosen as Average to Above Average (see Table 1b). Photo from Klohn Crippen Berger (2018).

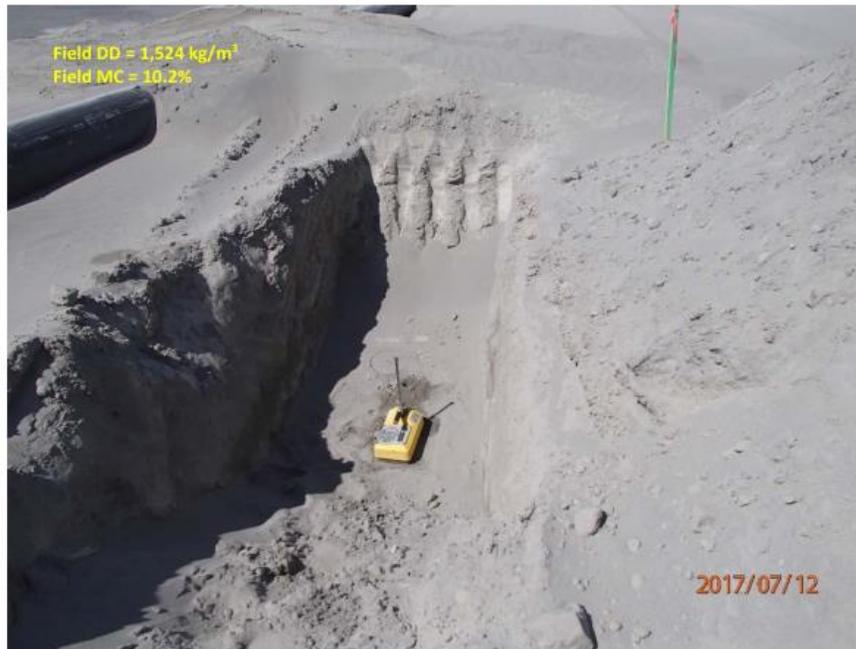
Figure 20b. Nuclear densometers are used to monitor the in-situ density of the uncompacted cycloned sands that are used to raise the tailings dams. The as-built reports by AMEC (2016a) and Klohn Crippen Berger (2017b, 2018, 2019) document extensive testing of construction material. However, as the above photo of a nuclear densometer in a test pit at a depth of 1.2 meters indicates, this testing has been carried out only on the material (uncompacted cycloned sand) that had been used to raise the tailings dams since the previous annual report. By contrast, there is essentially no documentation of any testing that occurred prior to 2015. Tetra Tech (2022) described the construction material for the starter dams (constructed in 1971) as “random” and stated that “there is limited data on the compacted cycloned sands that were used to construct the dam shell prior to 1980.” In fact, prior to 2015, it does not appear that construction was even carried out in accordance with the design. According to Tetra Tech (2022), “The reactivation design also called for a rockfill zone at the toe of the dams, extending back to the pre-2011 dam slope and 40 to 50 m above the dam toe. However, there is no indication that this was ever built; based on as-built records (KCB 2021b) [Klohn Crippen Berger (2021) in this report], the zone where rockfill was proposed to be used was constructed of cyclone sand ... The reactivation design also called for slope drains, similar in design to the 2014 crest drain (AMEC 2011), to be laid along the downstream slopes of the dams, but there is no evidence that these were installed.” Based on the contrast between the current quality of testing and the pre-2015 testing, as well as the extensive construction that occurred prior to 2015, the category for Level of Engineering in the area of Design – Testing was chosen as Average to Above Average (see Table 1b). Photo from Klohn Crippen Berger (2018).

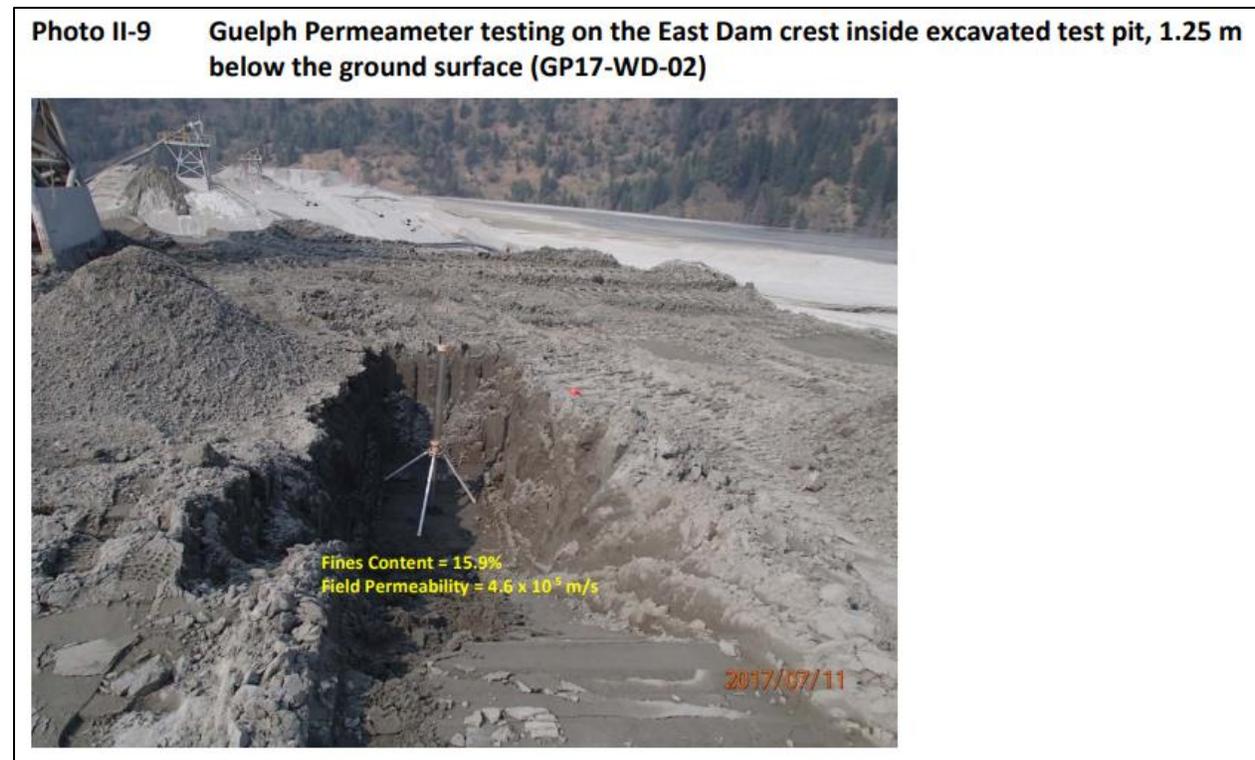
Figure 20c. Guelph permeameters are used to measure the in-situ saturated hydraulic conductivity of the uncompacted cycloned sands that are used to raise the tailings dams. The as-built reports by AMEC (2016a) and Klohn Crippen Berger (2017b, 2018, 2019) document extensive testing of construction material. However, as the above photo of a Guelph permeameter in a test pit at a depth of 1.25 meters indicates, this testing has been carried out only on the material (uncompacted cycloned sand) that had been used to raise the tailings dams since the previous annual report. By contrast, there is essentially no documentation of any testing that occurred prior to 2015. Tetra Tech (2022) described the construction material for the starter dams (constructed in 1971) as “random” and stated that “there is limited data on the compacted cycloned sands that were used to construct the dam shell prior to 1980.” In fact, prior to 2015, it does not appear that construction was even carried out in accordance with the design. According to Tetra Tech (2022), “The reactivation design also called for a rockfill zone at the toe of the dams, extending back to the pre-2011 dam slope and 40 to 50 m above the dam toe. However, there is no indication that this was ever built; based on as-built records (KCB 2021b) [Klohn Crippen Berger (2021) in this report], the zone where rockfill was proposed to be used was constructed of cyclone sand ... The reactivation design also called for slope drains, similar in design to the 2014 crest drain (AMEC 2011), to be laid along the downstream slopes of the dams, but there is no evidence that these were installed.” Based on the contrast between the current quality of testing and the pre-2015 testing, as well as the extensive construction that occurred prior to 2015, the category for Level of Engineering in the area of Design – Testing was chosen as Average to Above Average (see Table 1b). Photo from Klohn Crippen Berger (2018).

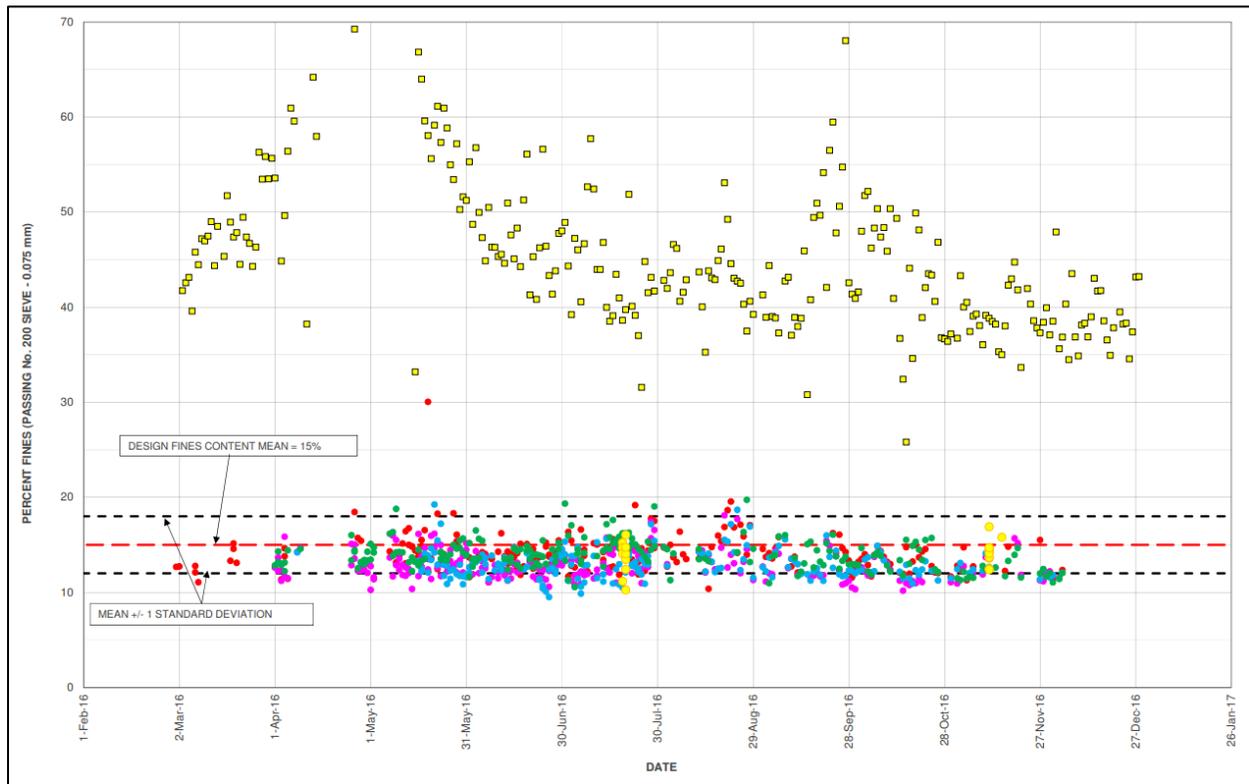
Figure 29. The above figure illustrates the effectiveness of the cyclones at reducing the content of fine-grained tailings to the design mean fines content of 15% in the cycloned sands that are used to construct the dam raises (see Fig. 16). In the figure, the gold squares indicate the fines content of the tailings as they arrive from the ore processing plant, while the colored circles indicate the outputs of the various cyclones. The figure is consistent with the characteristics of “construction control tests by qualified engineers and technicians” and “construction report clearly documents construction activities” for Level of Engineering in the category Best in the area Construction (see Table 1d). However, such documentation is available only for the dam raises that occurred beginning in 2015. By contrast, Tetra Tech (2022) described the construction material for the starter dams (constructed in 1971) as “random” and stated that “there is limited data on the compacted cycloned sands that were used to construct the dam shell prior to 1980.” In fact, prior to 2015, it does not appear that construction was even carried out in accordance with the design. According to Tetra Tech (2022), “The reactivation design also called for a rockfill zone at the toe of the dams, extending back to the pre-2011 dam slope and 40 to 50 m above the dam toe. However, there is no indication that this was ever built; based on as-built records (KCB 2021b) [Klohn Crippen Berger (2021) in this report], the zone where rockfill was proposed to be used was constructed of cyclone sand ... The reactivation design also called for slope drains, similar in design to the 2014 crest drain (AMEC 2011), to be laid along the downstream slopes of the dams, but there is no evidence that these were installed.” Based on the contrast between the current and the pre-2015 quality control and construction reporting, and taking into account the extensive construction that occurred prior to 2015, as well as the ongoing lack of full-time supervision by a qualified engineer (see Fig. 31), the category for Level of Engineering in the area of Construction was chosen as Above Average (see Table 1d). Figure from Klohn Crippen Berger (2017b).

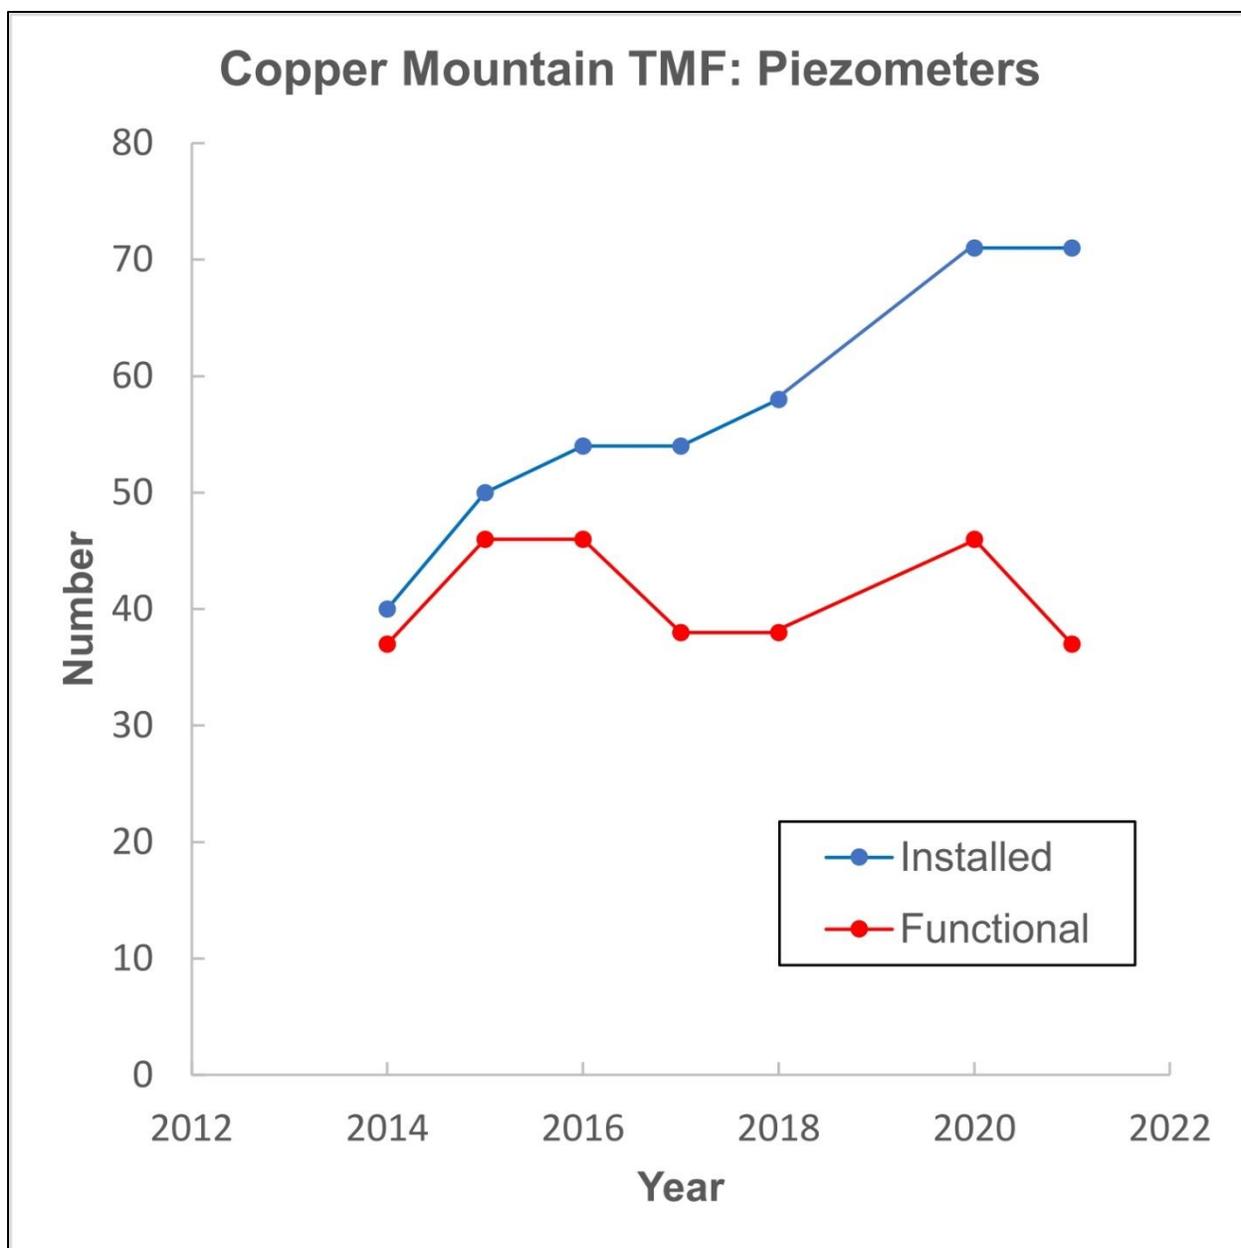
Figure 32. Since 2015 the number of functional piezometers at the Copper Mountain Tailings Management Facility has varied between 37 and 46, and was at an all-time low at the end of 2021. The 2021 Dam Safety Review critiqued the lack of piezometers and the resultant inability to adequately define the phreatic surface (water table) for calculation of the factor of safety (see Figs. 27a-b). The category Best for Level of Engineering in the area Operation and Monitoring would require “No malfunctions” and “Continuous maintenance by trained crews,” implying that annual dam safety inspections should not report non-functional instrumentation (see Table 1e). The category Above Average would require “no uncorrected malfunctions,” implying that non-functional instruments should be repaired or replaced. However, a characteristic of the category Average is “no field measurements,” implying the absence of any piezometers. On the above basis, the category for Level of Engineering in the area of Operation and Monitoring was chosen as Average to Above Average (see Table 1e). The choice is also consistent with the lack of a “complete performance program including comparison between predicted and measured performance (e.g., pore pressure, strength, deformations),” which would be required by the category Best. Finally, the choice is consistent with the existence of both periodic and annual inspections by qualified engineers that is required by the categories Above Average and Average, respectively. Data from AMEC (2014, 2016a) and Kloth Crippen Berger (2017b, 2018, 2019, 2021, 2022a).

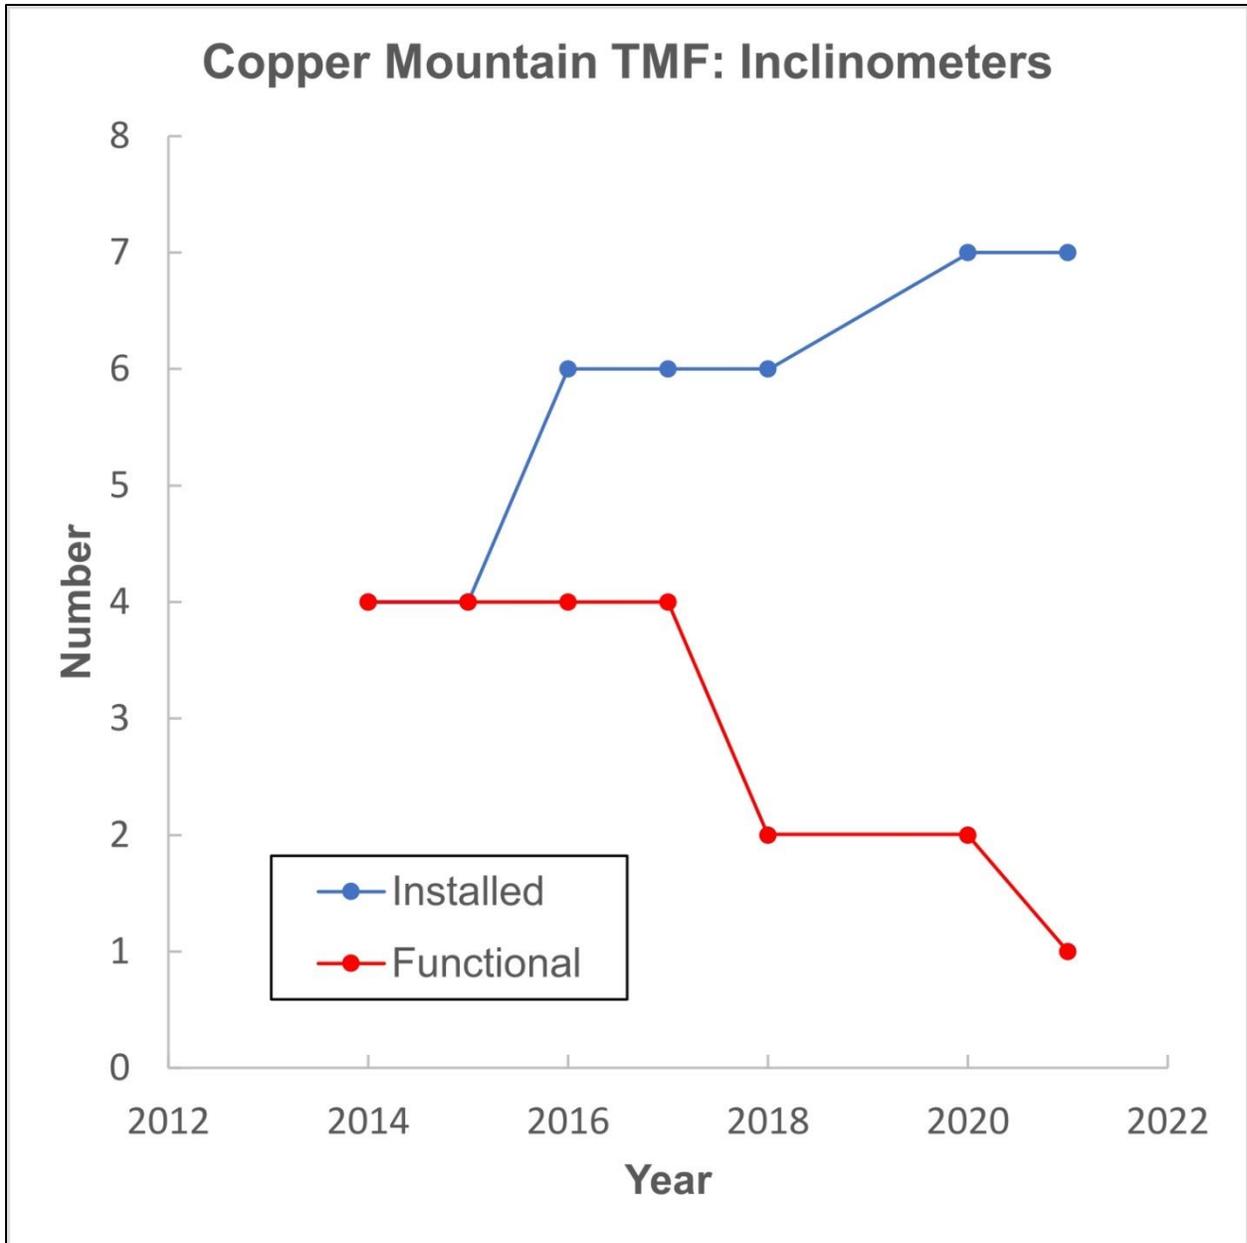
Figure 33. Since 2015 the number of functional inclinometers at the Copper Mountain Tailings Management Facility has steadily dropped until only one functional inclinometer remained at the end of 2021. The category Best for Level of Engineering in the area Operation and Monitoring would require “No malfunctions” and “Continuous maintenance by trained crews,” implying that annual dam safety inspections should not report non-functional instrumentation (see Table 1e). The category Above Average would require “no uncorrected malfunctions,” implying that non-functional instruments should be repaired or replaced. However, a characteristic of the category Average is “no field measurements,” implying the absence of any piezometers. On the above basis, the category for Level of Engineering in the area of Operation and Monitoring was chosen as Average to Above Average (see Table 1e). The choice is also consistent with the lack of a “complete performance program including comparison between predicted and measured performance (e.g., pore pressure, strength, deformations),” which would be required by the category Best. Finally, the choice is consistent with the existence of both periodic and annual inspections by qualified engineers that is required by the categories Above Average and Average, respectively. Data from AMEC (2014, 2016a) and Klohn Crippen Berger (2017b, 2018, 2019, 2021, 2022a).

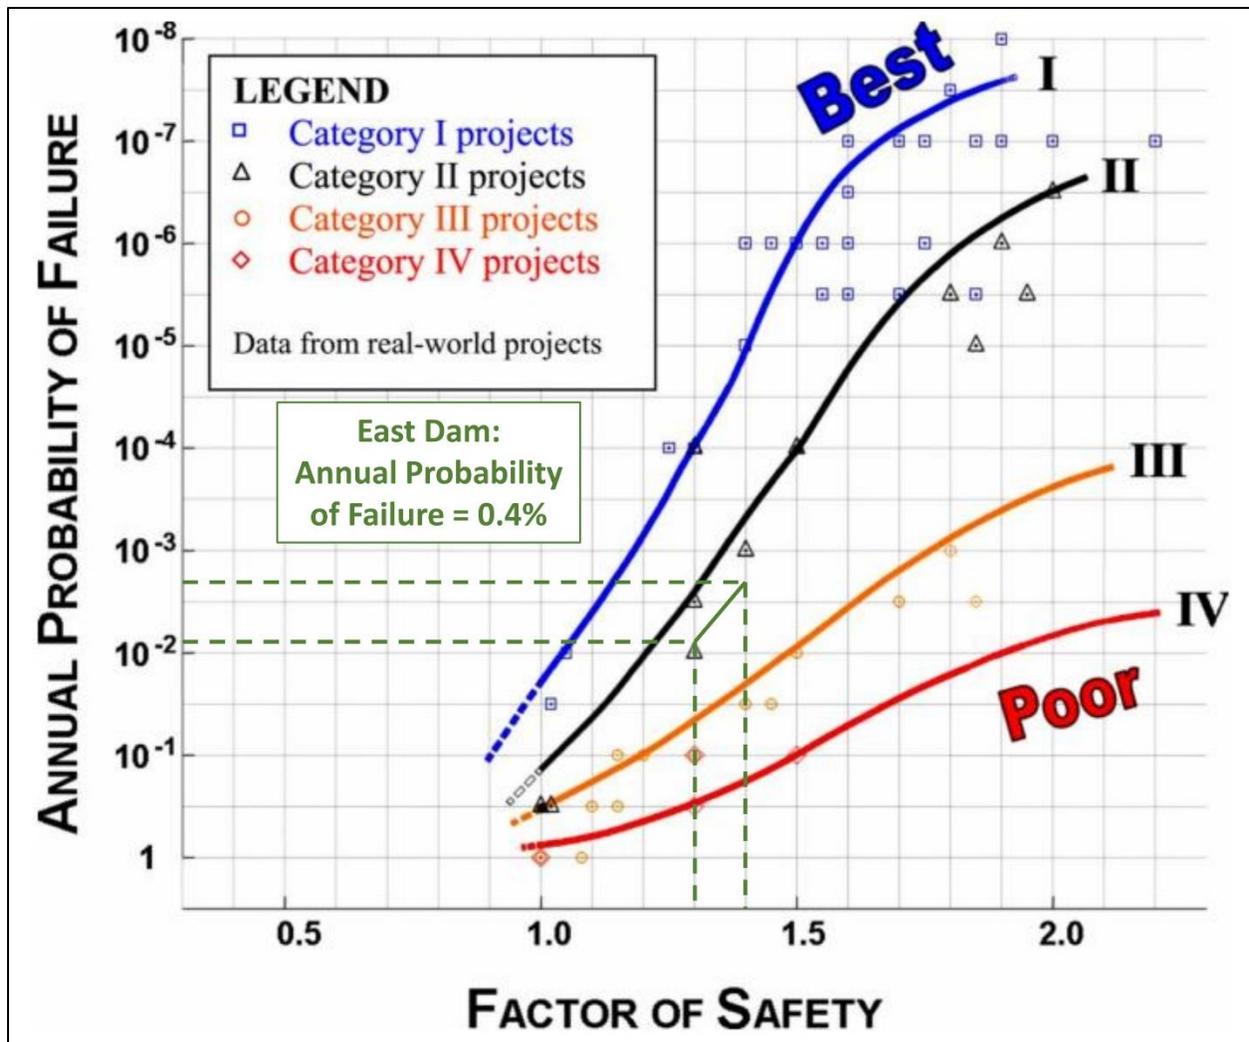
Figure 34a. Based upon calculated factors of safety of $FS = 1.3$ and $FS = 1.4$ (see Fig. 26a) and an overall Level of Engineering of 2.4 (where Above Average = 2 and Average = 3) (see Tables 1a-e), the annual probability of failure of the East Dam was estimated in the range 0.2-0.8% with a best estimate of 0.4%. Based upon the best estimate for the annual probability of failure of the West Dam as 0.05% (see Fig. 34b), the best estimate for the annual probability of failure of the Copper Mountain Tailings Management Facility is 0.45%. Taking into consideration the amount of judgment required in the calculation of the Level of Engineering, the annual probability of failure should be regarded as the range 0.1-1% (1 in 1000 to 1 in 100). Figure modified from Silva et al. (2008).

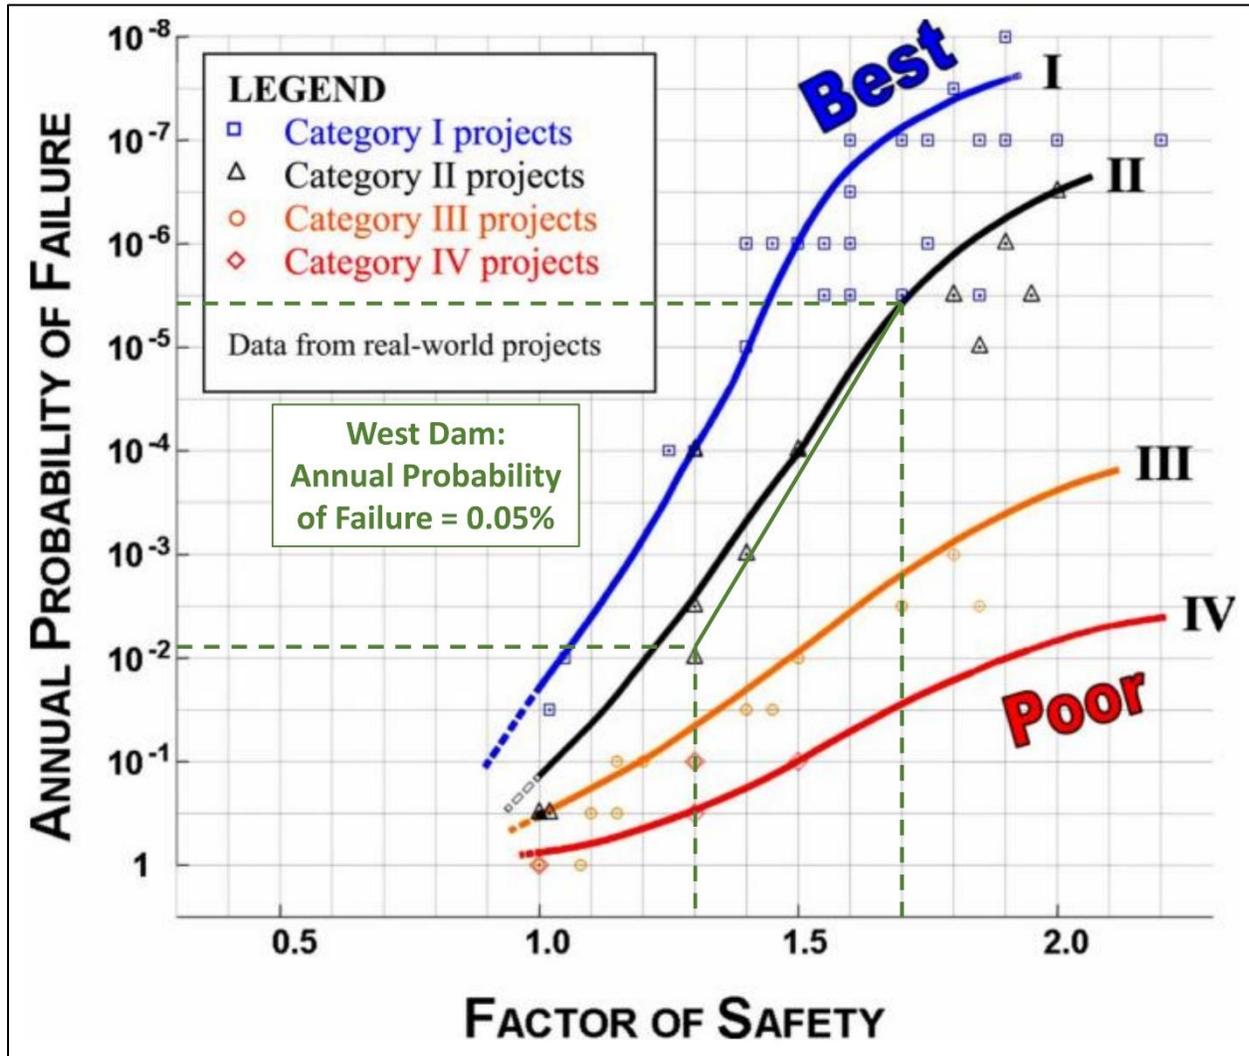
Figure 34b. Based upon calculated factors of safety of FS = 1.3 and FS = 1.7 (see Fig. 26b) and an overall Level of Engineering of 2.4 (where Above Average = 2 and Average = 3) (see Tables 1a-e), the annual probability of failure of the West Dam was estimated in the range 0.004-0.8% with a best estimate of 0.05%. Based upon the best estimate for the annual probability of failure of the East Dam as 0.4% (see Fig. 34a), the best estimate for the annual probability of failure of the Copper Mountain Tailings Management Facility is 0.45%. Taking into consideration the amount of judgment required in the calculation of the Level of Engineering, the annual probability of failure should be regarded as the range 0.1-1% (1 in 1000 to 1 in 100). Figure modified from Silva et al. (2008).
