# **The Use of the Silva-Lambe-Marr Method for Estimating the Annual Probability of Failure of the Tailings Dams at the Copper Mountain Mine, British Columbia, Canada**

Steven H. Emerman, Ph.D., Malach Consulting, LLC, 785 N 200 W, Spanish Fork, Utah 84660, USA, Tel: 1-801-921-1228, E-mail: SHEmerman@gmail.com

Report prepared for Confederated Tribes of the Colville Reservation, submitted July 1, 2022

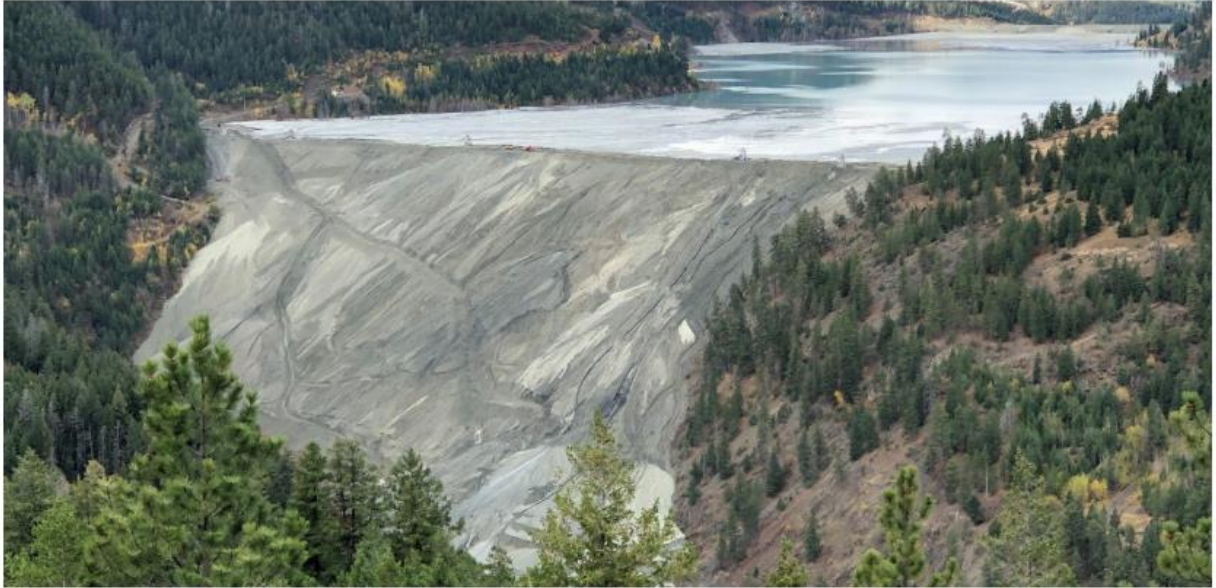
**Photo II-1 East Dam downstream slope looking west from the Copper Mountain Road (October 14, 2020)**

**Figure 3a.** At the end of 2022, the crest of the East Dam will be 973 meters above sea level, corresponding to an approximate height of 172.5 meters. The permitted crest elevation of 997 meters above sea level (corresponding to an approximate height of 196.5 meters) will be achieved in 2027. Photo from Klohn Crippen Berger (2021).

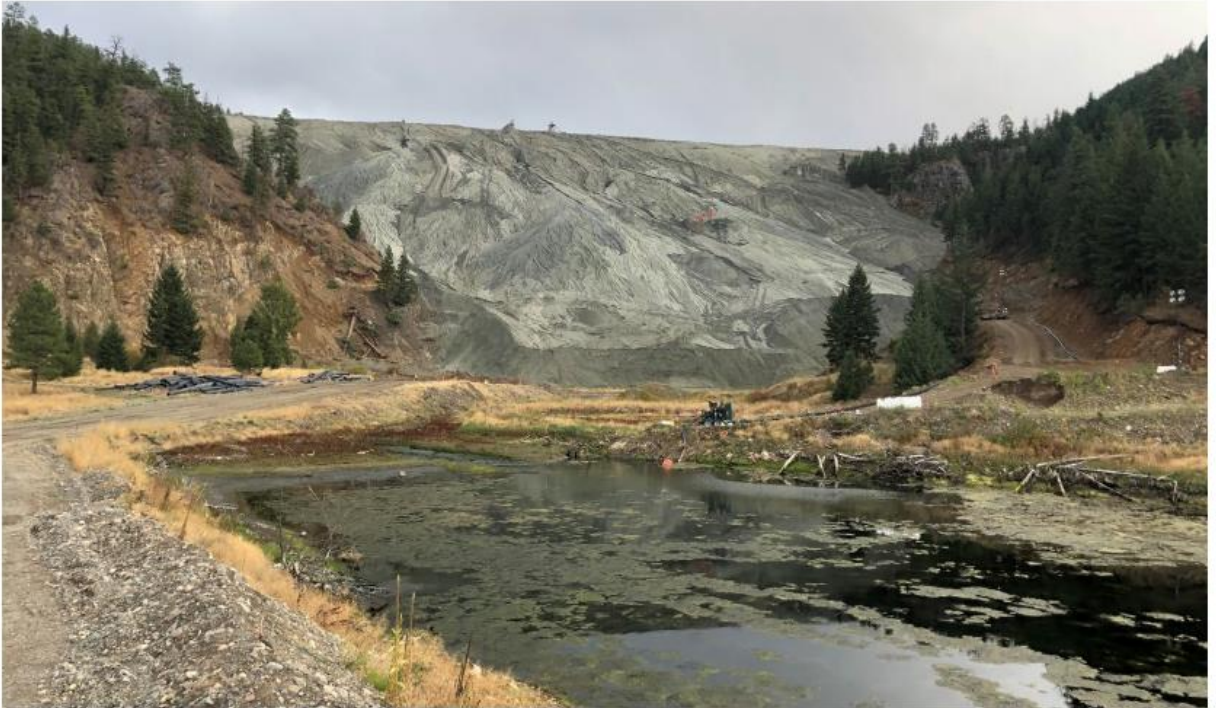
**Photo II-26 West Dam downstream slope looking east from toe seepage pond (October 14, 2020)**

**Figure 3b.** At the end of 2022, the crest of the West Dam will be 973 meters above sea level, corresponding to an approximate height of 164.5 meters. The permitted crest elevation of 997 meters above sea level (corresponding to an approximate height of 188.5 meters) will be achieved in 2027. Photo from Klohn Crippen Berger (2021).

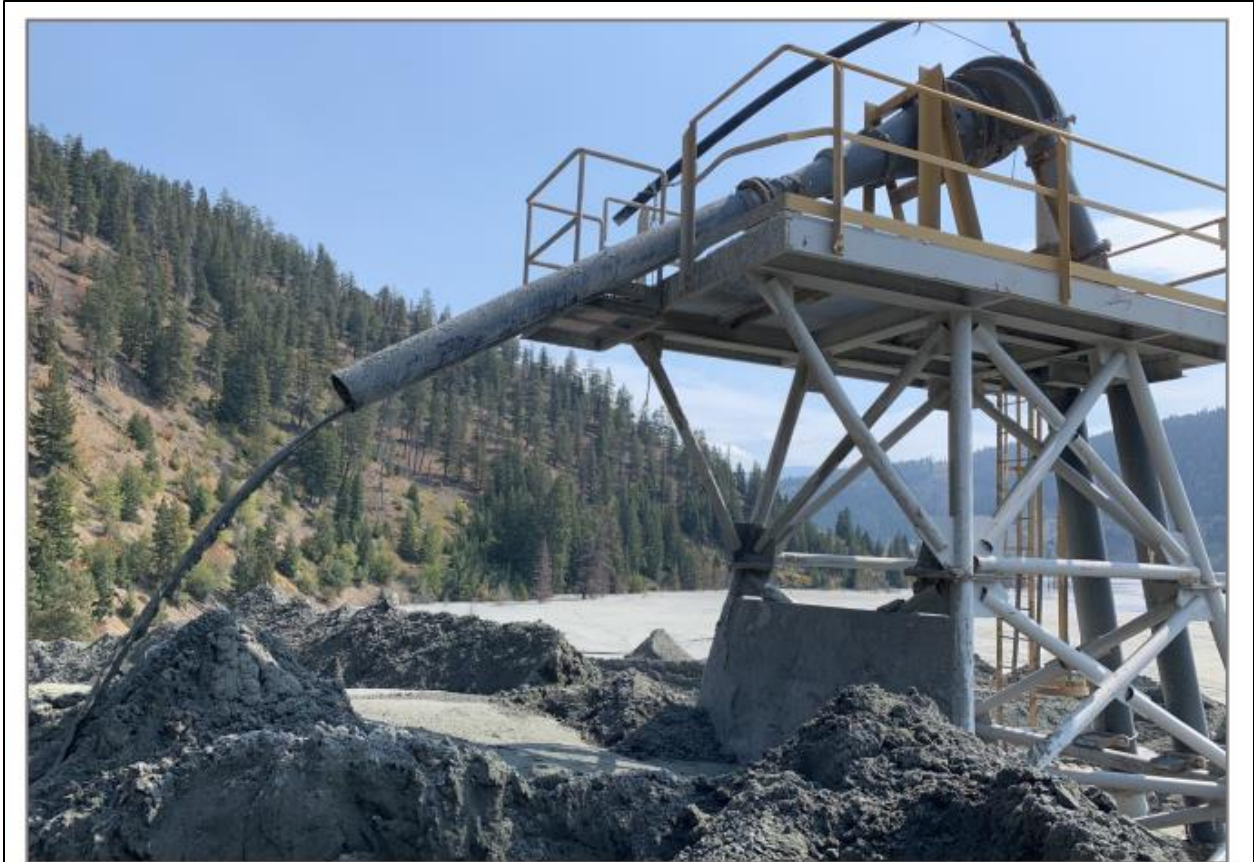
**Photo 16:** Cyclone discharging underflow (cyclone sand) on downstream face of West Dam

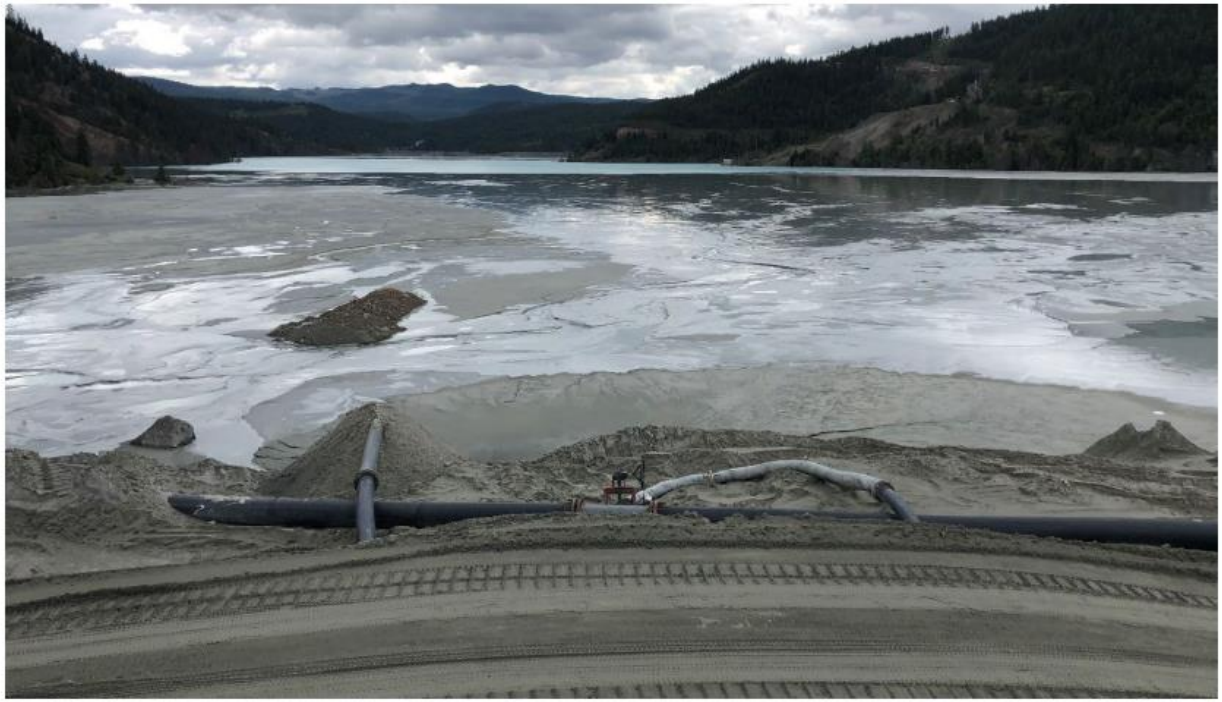
**Figure 17a.** The overflow from the cyclones (see Fig. 16) consisting of finer tailings and water is discharged from the crest of the West Dam toward the interior of the tailings management facility. The coarser fraction of the overflow settles closer to the dam crest to form a tailings beach (foreground of photo; compare with Figs. 2 and 11). The finest fraction of the overflow (slimes) is carried to the interior of the tailings management facility (background of photo; compare with Figs. 2 and 11). Photo from Tetra Tech (2022).

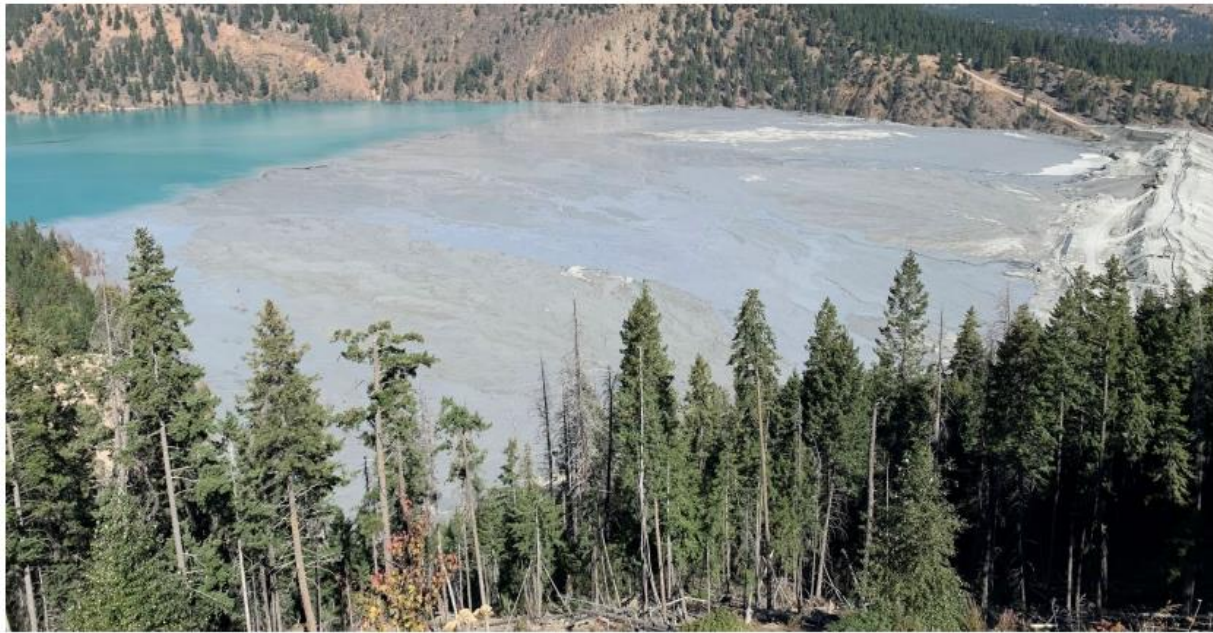
**Figure 17b.** The overflow from the cyclones (see Fig. 16) consisting of finer tailings and water is discharged from the crest of the East Dam toward the interior of the tailings management facility. The coarser fraction of the overflow settles closer to the dam crest to form a tailings beach (middle to right-hand side of photo; compare with Figs. 2 and 11). The finest fraction of the overflow (slimes) is carried to the interior of the tailings management facility (left-hand side of photo; compare with Figs. 2 and 11). Photo from Tetra Tech (2022).

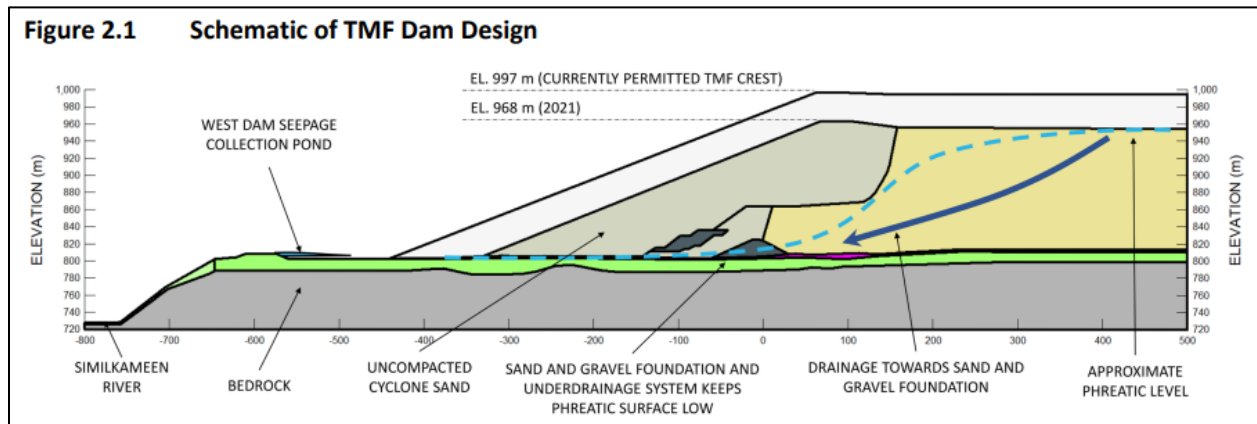
**Figure 18.** The cross-section of the West Dam clarifies that, despite the use of the term “modified centerline,” the tailings dams at the Copper Mountain mine are constructed using the upstream method, in that the dikes (uncompacted cycloned sand) are constructed on top of the uncompacted, fine-grained tailings (tan color) that they are impounding (compare with Figs. 12a, 13 and 14). The upstream construction method is the cheapest because it requires the least amount of construction material (compare Figs. 12a-c). The method is also the most dangerous because, if the underlying tailings liquefy, the dikes can fail by falling into or sliding over the liquefied tailings even if the dikes temporarily maintain their structural integrity. The upstream construction method is prohibited in Brazil, Chile, Ecuador and Peru. Figure from Klohn Crippen Berger (2022a).

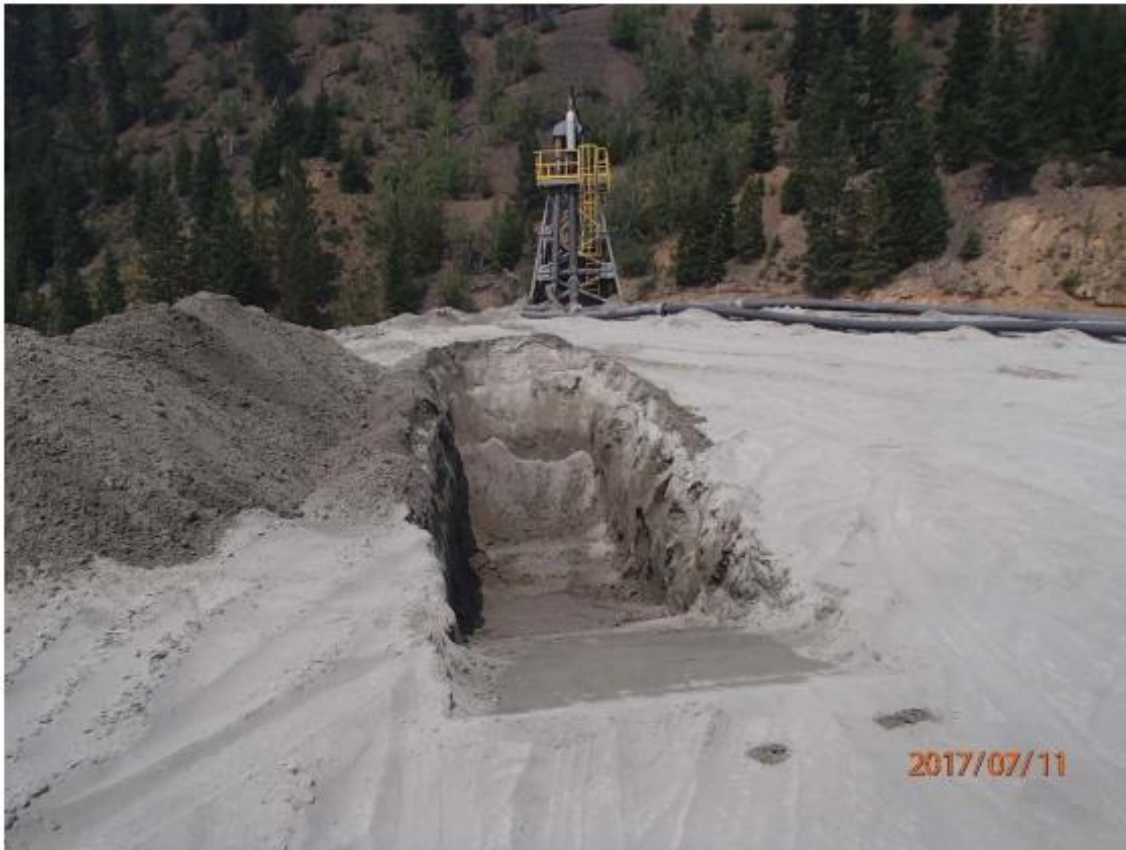
**Figure 20a.** The as-built reports by AMEC (2016a) and Klohn Crippen Berger (2017b, 2018, 2019) document extensive testing of construction material. However, as the above photo of a test pit indicates, this testing was carried out only on the material (uncompacted cycloned sand) that had been used to raise the tailings dams since the previous annual report. By contrast, there is essentially no documentation of any testing that occurred prior to 2015. Tetra Tech (2022) described the construction material for the starter dams (constructed in 1971) as “random” and stated that “there is limited data on the compacted cycloned sands that were used to construct the dam shell prior to 1980.” In fact, prior to 2015, it does not appear that construction was even carried out in accordance with the design. According to Tetra Tech (2022), “The reactivation design also called for a rockfill zone at the toe of the dams, extending back to the pre-2011 dam slope and 40 to 50 m above the dam toe. However, there is no indication that this was ever built; based on as-built records (KCB 2021b) [Klohn Crippen Berger (2021) in this report], the zone where rockfill was proposed to be used was constructed of cyclone sand ... The reactivation design also called for slope drains, similar in design to the 2014 crest drain (AMEC 2011), to be laid along the downstream slopes of the dams, but there is no evidence that these were installed.” Based on the contrast between the current quality of testing and the pre-2015 testing, as well as the extensive construction that occurred prior to 2015, the category for Level of Engineering in the area of Design – Testing was chosen as Average to Above Average (see Table 1b). Photo from Klohn Crippen Berger (2018).

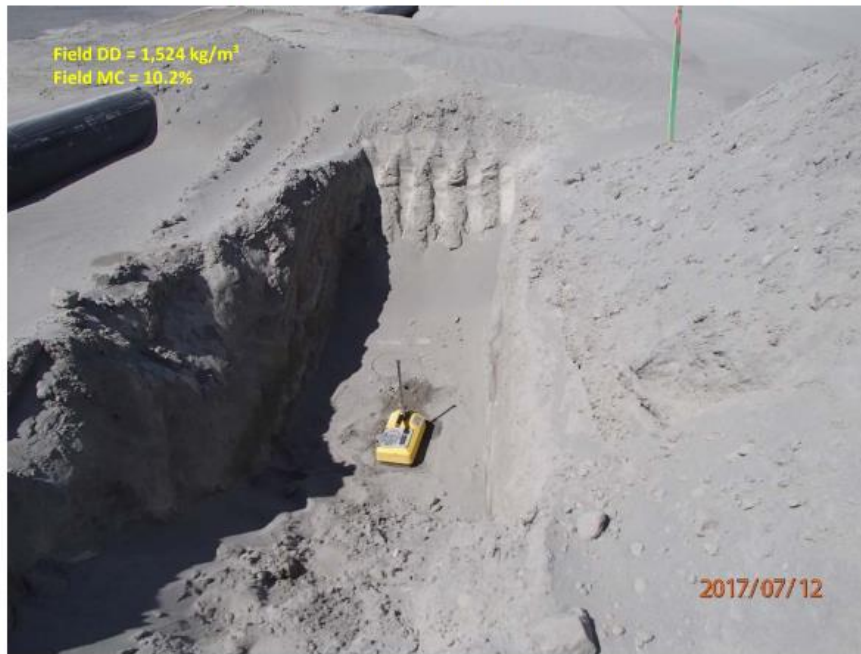
**Figure 20b.** Nuclear densometers are used to monitor the in-situ density of the uncompacted cycloned sands that are used to raise the tailings dams. The as-built reports by AMEC (2016a) and Klohn Crippen Berger (2017b, 2018, 2019) document extensive testing of construction material. However, as the above photo of a nuclear densometer in a test pit at a depth of 1.2 meters indicates, this testing has been carried out only on the material (uncompacted cycloned sand) that had been used to raise the tailings dams since the previous annual report. By contrast, there is essentially no documentation of any testing that occurred prior to 2015. Tetra Tech (2022) described the construction material for the starter dams (constructed in 1971) as “random” and stated that “there is limited data on the compacted cycloned sands that were used to construct the dam shell prior to 1980.” In fact, prior to 2015, it does not appear that construction was even carried out in accordance with the design. According to Tetra Tech (2022), “The reactivation design also called for a rockfill zone at the toe of the dams, extending back to the pre-2011 dam slope and 40 to 50 m above the dam toe. However, there is no indication that this was ever built; based on as-built records (KCB 2021b) [Klohn Crippen Berger (2021) in this report], the zone where rockfill was proposed to be used was constructed of cyclone sand ... The reactivation design also called for slope drains, similar in design to the 2014 crest drain (AMEC 2011), to be laid along the downstream slopes of the dams, but there is no evidence that these were installed.” Based on the contrast between the current quality of testing and the pre-2015 testing, as well as the extensive construction that occurred prior to 2015, the category for Level of Engineering in the area of Design – Testing was chosen as Average to Above Average (see Table 1b). Photo from Klohn Crippen Berger (2018).

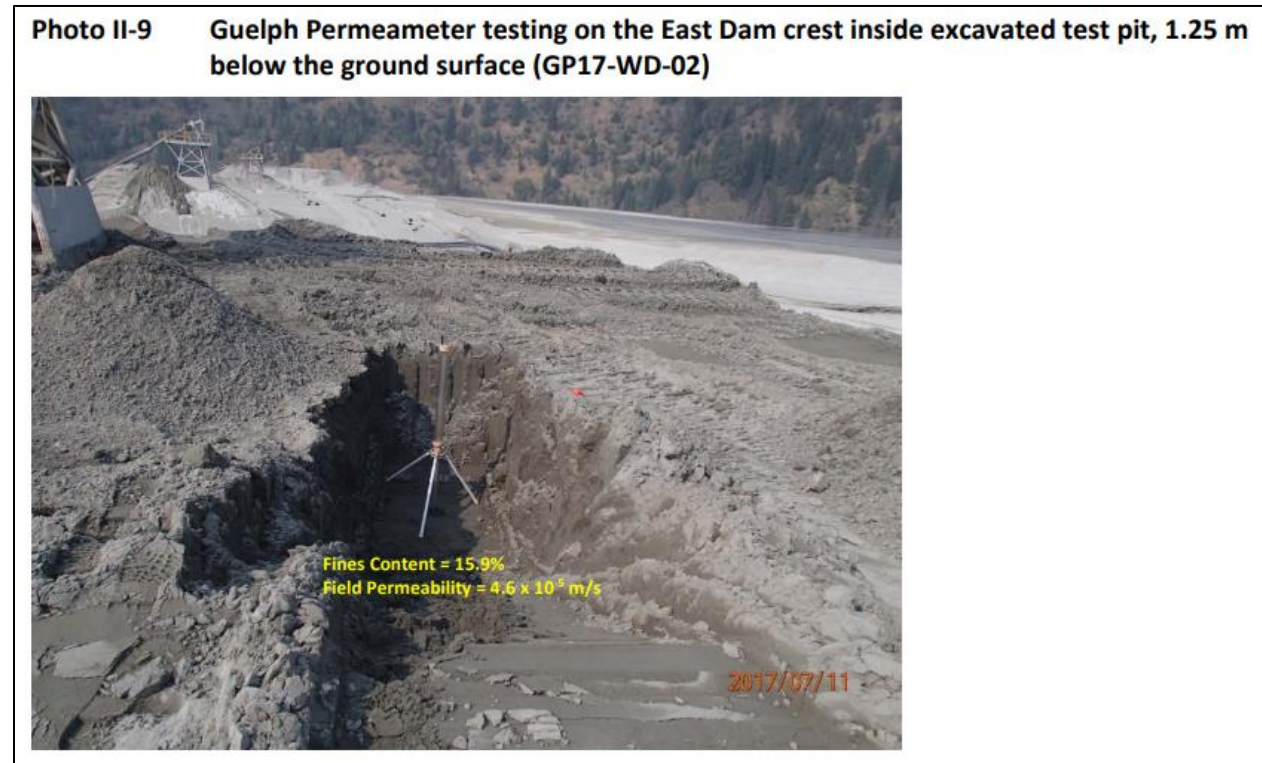
**Figure 20c.** Guelph permeameters are used to measure the in-situ saturated hydraulic conductivity of the uncompacted cycloned sands that are used to raise the tailings dams. The as-built reports by AMEC (2016a) and Klohn Crippen Berger (2017b, 2018, 2019) document extensive testing of construction material. However, as the above photo of a Guelph permeameter in a test pit at a depth of 1.25 meters indicates, this testing has been carried out only on the material (uncompacted cycloned sand) that had been used to raise the tailings dams since the previous annual report. By contrast, there is essentially no documentation of any testing that occurred prior to 2015. Tetra Tech (2022) described the construction material for the starter dams (constructed in 1971) as “random” and stated that “there is limited data on the compacted cycloned sands that were used to construct the dam shell prior to 1980.” In fact, prior to 2015, it does not appear that construction was even carried out in accordance with the design. According to Tetra Tech (2022), “The reactivation design also called for a rockfill zone at the toe of the dams, extending back to the pre-2011 dam slope and 40 to 50 m above the dam toe. However, there is no indication that this was ever built; based on as-built records (KCB 2021b) [Klohn Crippen Berger (2021) in this report], the zone where rockfill was proposed to be used was constructed of cyclone sand ... The reactivation design also called for slope drains, similar in design to the 2014 crest drain (AMEC 2011), to be laid along the downstream slopes of the dams, but there is no evidence that these were installed.” Based on the contrast between the current quality of testing and the pre-2015 testing, as well as the extensive construction that occurred prior to 2015, the category for Level of Engineering in the area of Design – Testing was chosen as Average to Above Average (see Table 1b). Photo from Klohn Crippen Berger (2018).

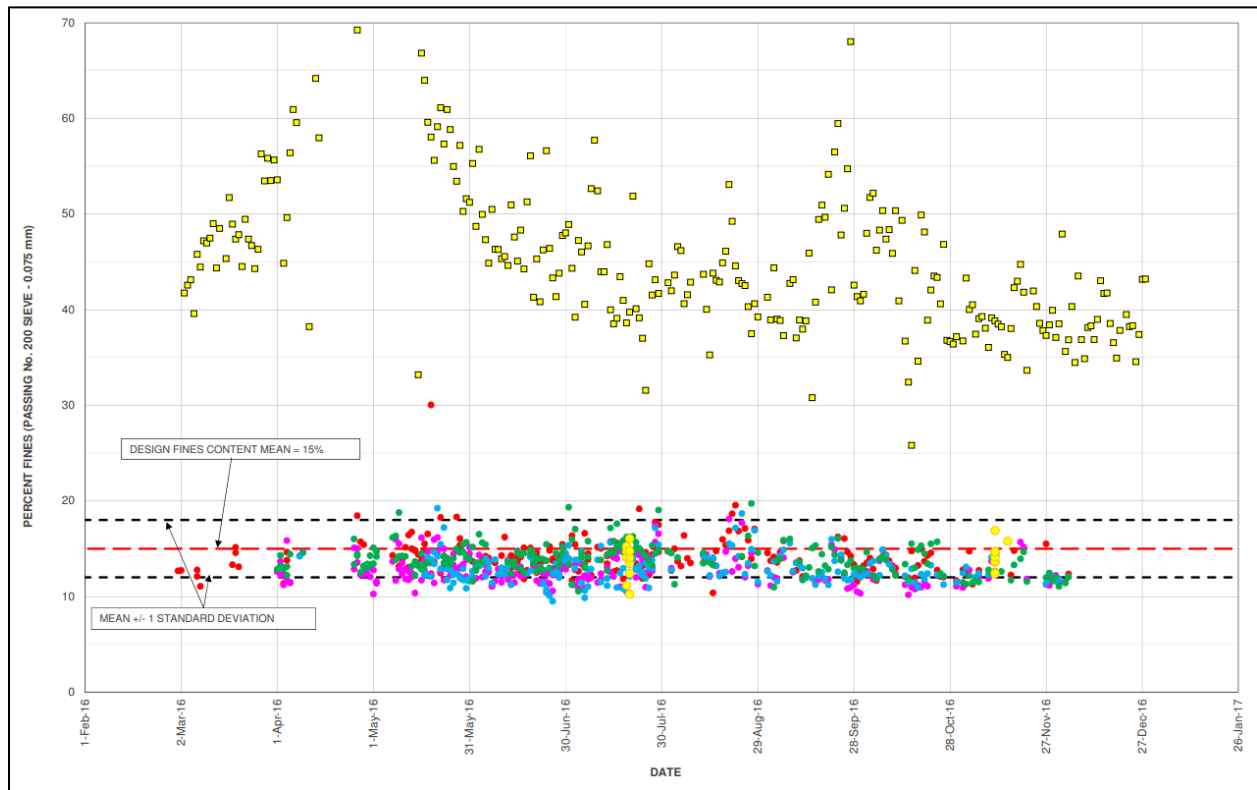
**Figure 29.** The above figure illustrates the effectiveness of the cyclones at reducing the content of fine-grained tailings to the design mean fines content of 15% in the cycloned sands that are used to construct the dam raises (see Fig. 16). In the figure, the gold squares indicate the fines content of the tailings as they arrive from the ore processing plant, while the colored circles indicate the outputs of the various cyclones. The figure is consistent with the characteristics of “construction control tests by qualified engineers and technicians” and “construction report clearly documents construction activities” for Level of Engineering in the category Best in the area Construction (see Table 1d). However, such documentation is available only for the dam raises that occurred beginning in 2015. By contrast, Tetra Tech (2022) described the construction material for the starter dams (constructed in 1971) as “random” and stated that “there is limited data on the compacted cycloned sands that were used to construct the dam shell prior to 1980.” In fact, prior to 2015, it does not appear that construction was even carried out in accordance with the design. According to Tetra Tech (2022), “The reactivation design also called for a rockfill zone at the toe of the dams, extending back to the pre-2011 dam slope and 40 to 50 m above the dam toe. However, there is no indication that this was ever built; based on as-built records (KCB 2021b) [Klohn Crippen Berger (2021) in this report], the zone where rockfill was proposed to be used was constructed of cyclone sand ... The reactivation design also called for slope drains, similar in design to the 2014 crest drain (AMEC 2011), to be laid along the downstream slopes of the dams, but there is no evidence that these were installed.” Based on the contrast between the current and the pre-2015 quality control and construction reporting, and taking into account the extensive construction that occurred prior to 2015, as well as the ongoing lack of full-time supervision by a qualified engineer (see Fig. 31), the category for Level of Engineering in the area of Construction was chosen as Above Average (see Table 1d). Figure from Klohn Crippen Berger (2017b).

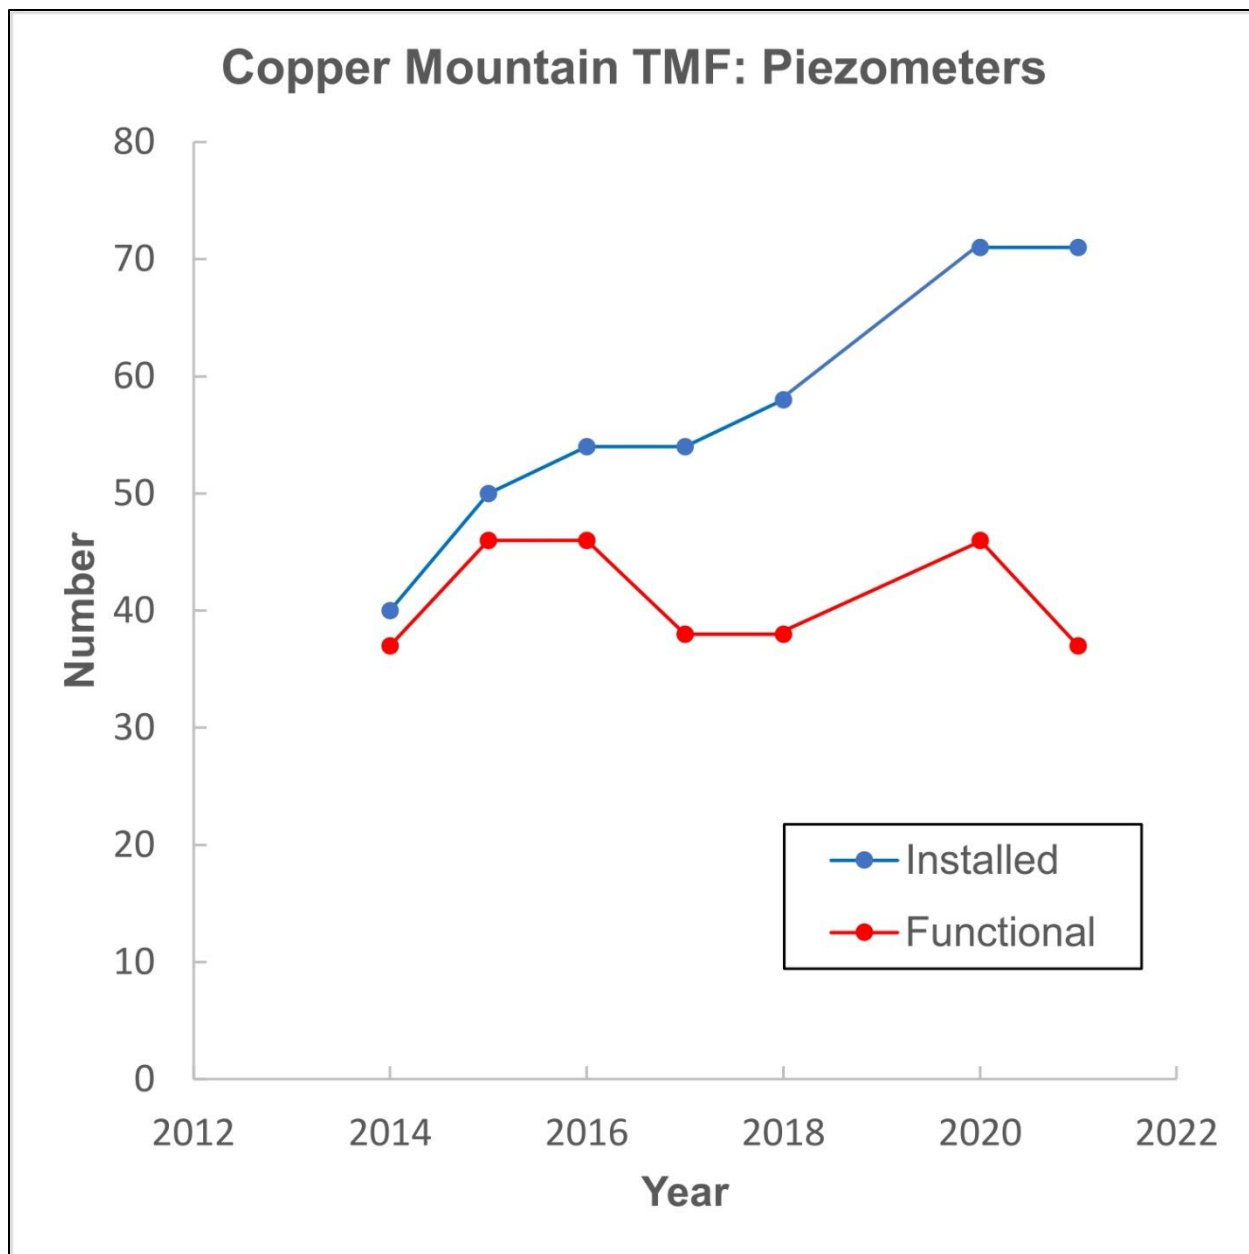
**Figure 32.** Since 2015 the number of functional piezometers at the Copper Mountain Tailings Management Facility has varied between 37 and 46, and was at an all-time low at the end of 2021. The 2021 Dam Safety Review critiqued the lack of piezometers and the resultant inability to adequately define the phreatic surface (water table) for calculation of the factor of safety (see Figs. 27a-b). The category Best for Level of Engineering in the area Operation and Monitoring would require “No malfunctions” and “Continuous maintenance by trained crews,” implying that annual dam safety inspections should not report non-functional instrumentation (see Table 1e). The category Above Average would require “no uncorrected malfunctions,” implying that non-functional instruments should be repaired or replaced. However, a characteristic of the category Average is “no field measurements,” implying the absence of any piezometers. On the above basis, the category for Level of Engineering in the area of Operation and Monitoring was chosen as Average to Above Average (see Table 1e). The choice is also consistent with the lack of a “complete performance program including comparison between predicted and measured performance (e.g., pore pressure, strength, deformations),” which would be required by the category Best. Finally, the choice is consistent with the existence of both periodic and annual inspections by qualified engineers that is required by the categories Above Average and Average, respectively. Data from AMEC (2014, 2016a) and Kloth Crippen Berger (2017b, 2018, 2019, 2021, 2022a).

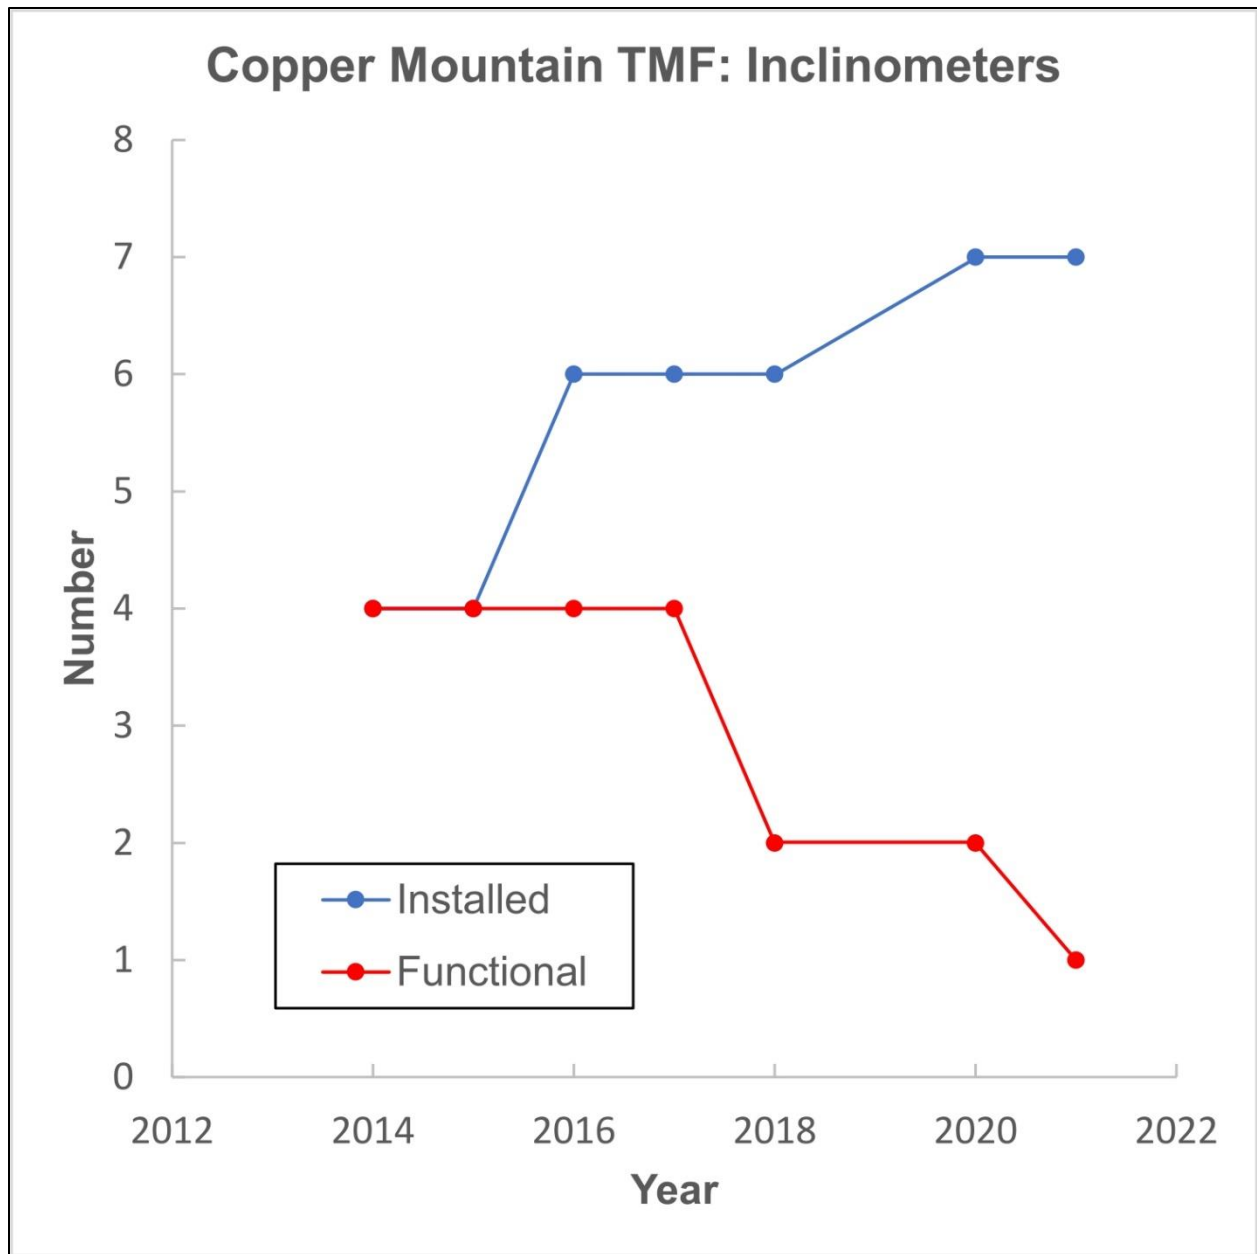
**Figure 33.** Since 2015 the number of functional inclinometers at the Copper Mountain Tailings Management Facility has steadily dropped until only one functional inclinometer remained at the end of 2021. The category Best for Level of Engineering in the area Operation and Monitoring would require “No malfunctions” and “Continuous maintenance by trained crews,” implying that annual dam safety inspections should not report non-functional instrumentation (see Table 1e). The category Above Average would require “no uncorrected malfunctions,” implying that non-functional instruments should be repaired or replaced. However, a characteristic of the category Average is “no field measurements,” implying the absence of any piezometers. On the above basis, the category for Level of Engineering in the area of Operation and Monitoring was chosen as Average to Above Average (see Table 1e). The choice is also consistent with the lack of a “complete performance program including comparison between predicted and measured performance (e.g., pore pressure, strength, deformations),” which would be required by the category Best. Finally, the choice is consistent with the existence of both periodic and annual inspections by qualified engineers that is required by the categories Above Average and Average, respectively. Data from AMEC (2014, 2016a) and Klohn Crippen Berger (2017b, 2018, 2019, 2021, 2022a).

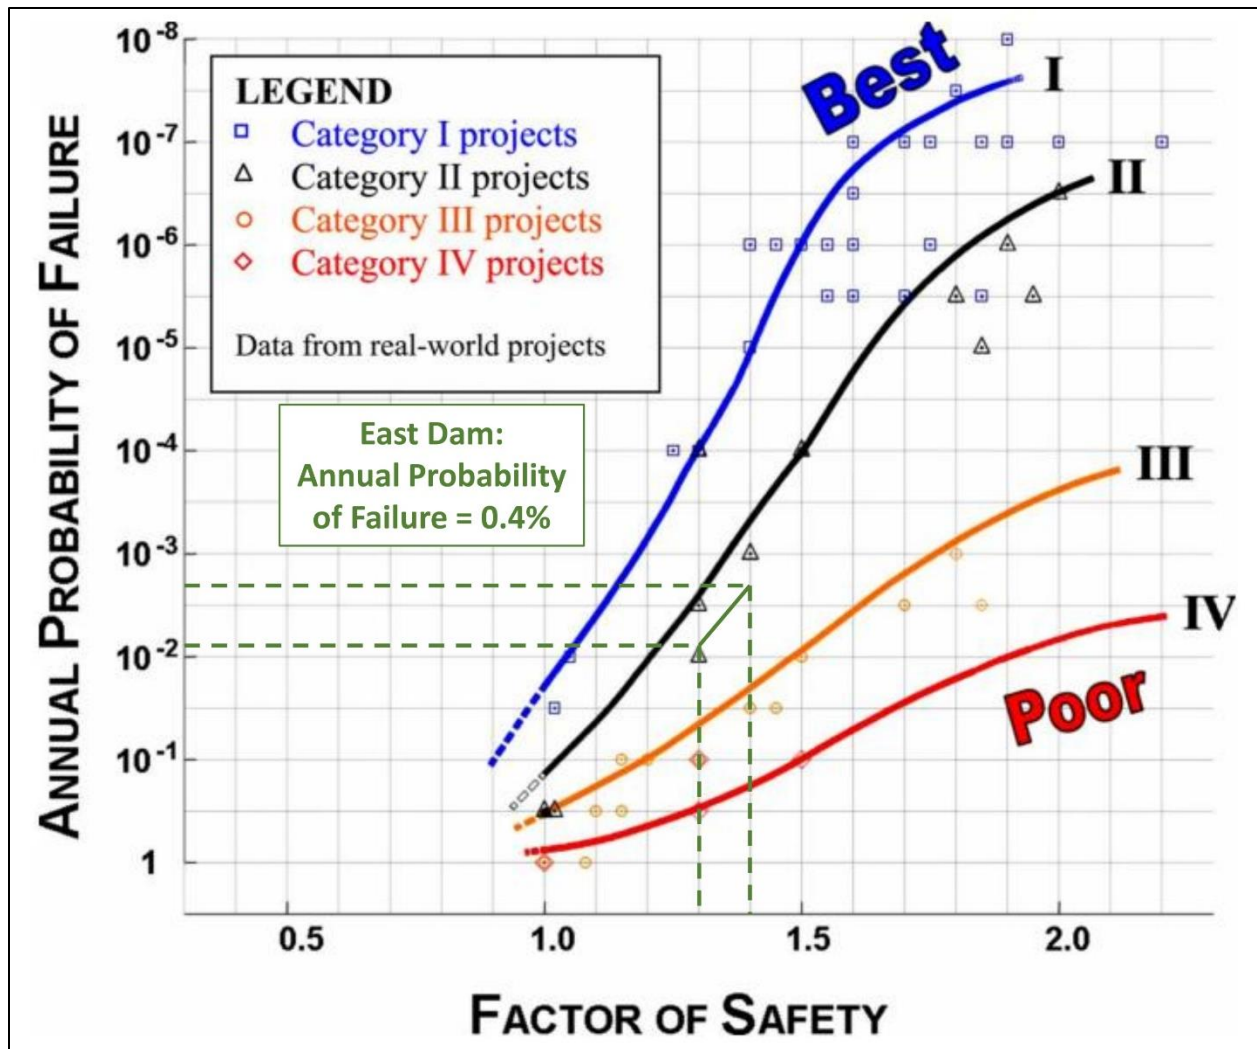
**Figure 34a.** Based upon calculated factors of safety of  $FS = 1.3$  and  $FS = 1.4$  (see Fig. 26a) and an overall Level of Engineering of 2.4 (where Above Average = 2 and Average = 3) (see Tables 1a-e), the annual probability of failure of the East Dam was estimated in the range 0.2-0.8% with a best estimate of 0.4%. Based upon the best estimate for the annual probability of failure of the West Dam as 0.05% (see Fig. 34b), the best estimate for the annual probability of failure of the Copper Mountain Tailings Management Facility is 0.45%. Taking into consideration the amount of judgment required in the calculation of the Level of Engineering, the annual probability of failure should be regarded as the range 0.1-1% (1 in 1000 to 1 in 100). Figure modified from Silva et al. (2008).

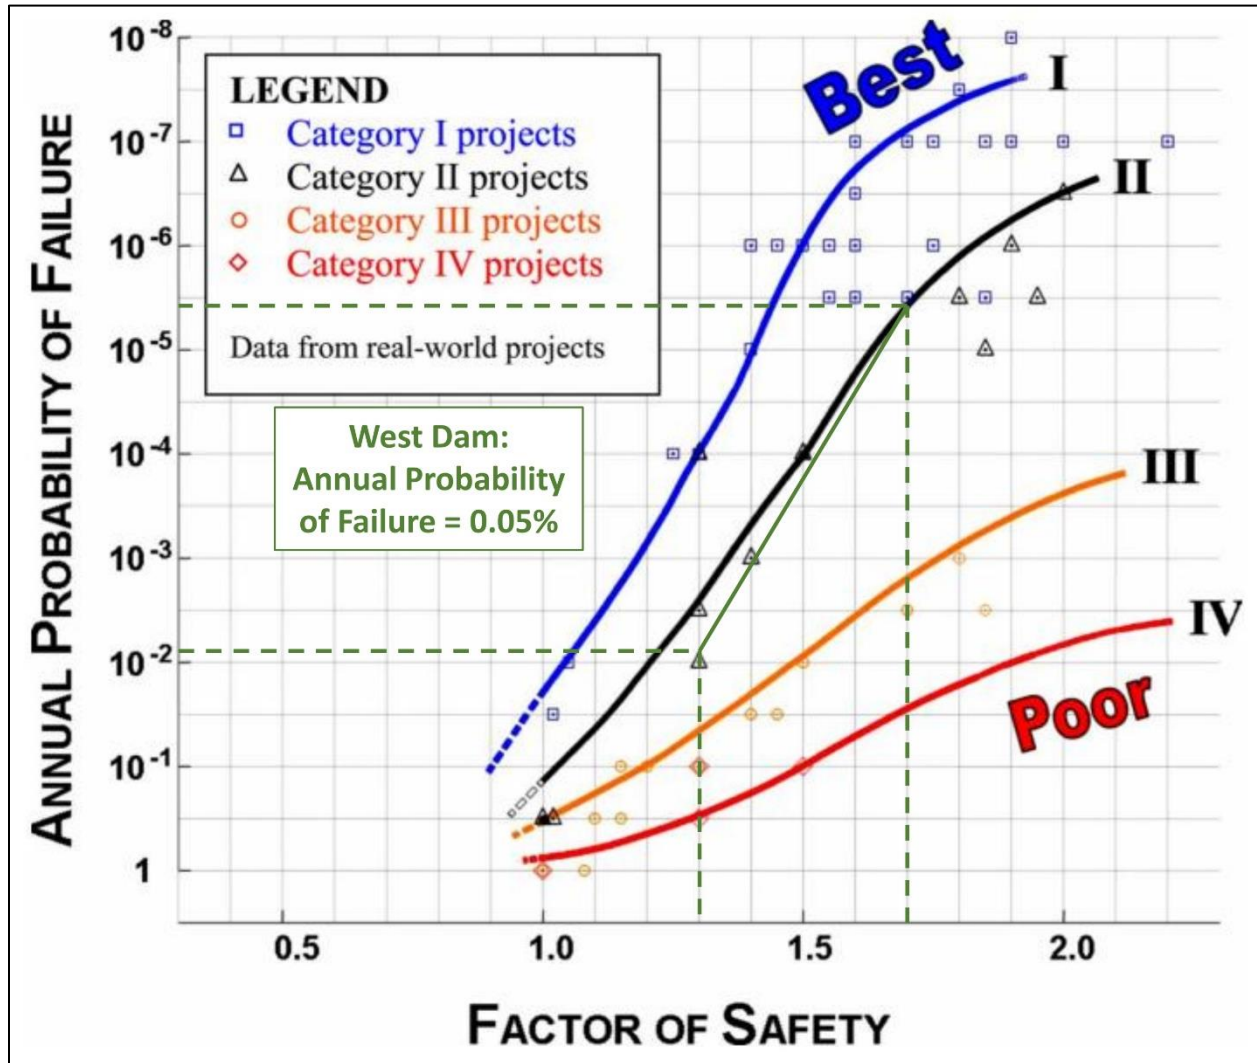
**Figure 34b.** Based upon calculated factors of safety of FS = 1.3 and FS = 1.7 (see Fig. 26b) and an overall Level of Engineering of 2.4 (where Above Average = 2 and Average = 3) (see Tables 1a-e), the annual probability of failure of the West Dam was estimated in the range 0.004-0.8% with a best estimate of 0.05%. Based upon the best estimate for the annual probability of failure of the East Dam as 0.4% (see Fig. 34a), the best estimate for the annual probability of failure of the Copper Mountain Tailings Management Facility is 0.45%. Taking into consideration the amount of judgment required in the calculation of the Level of Engineering, the annual probability of failure should be regarded as the range 0.1-1% (1 in 1000 to 1 in 100). Figure modified from Silva et al. (2008).

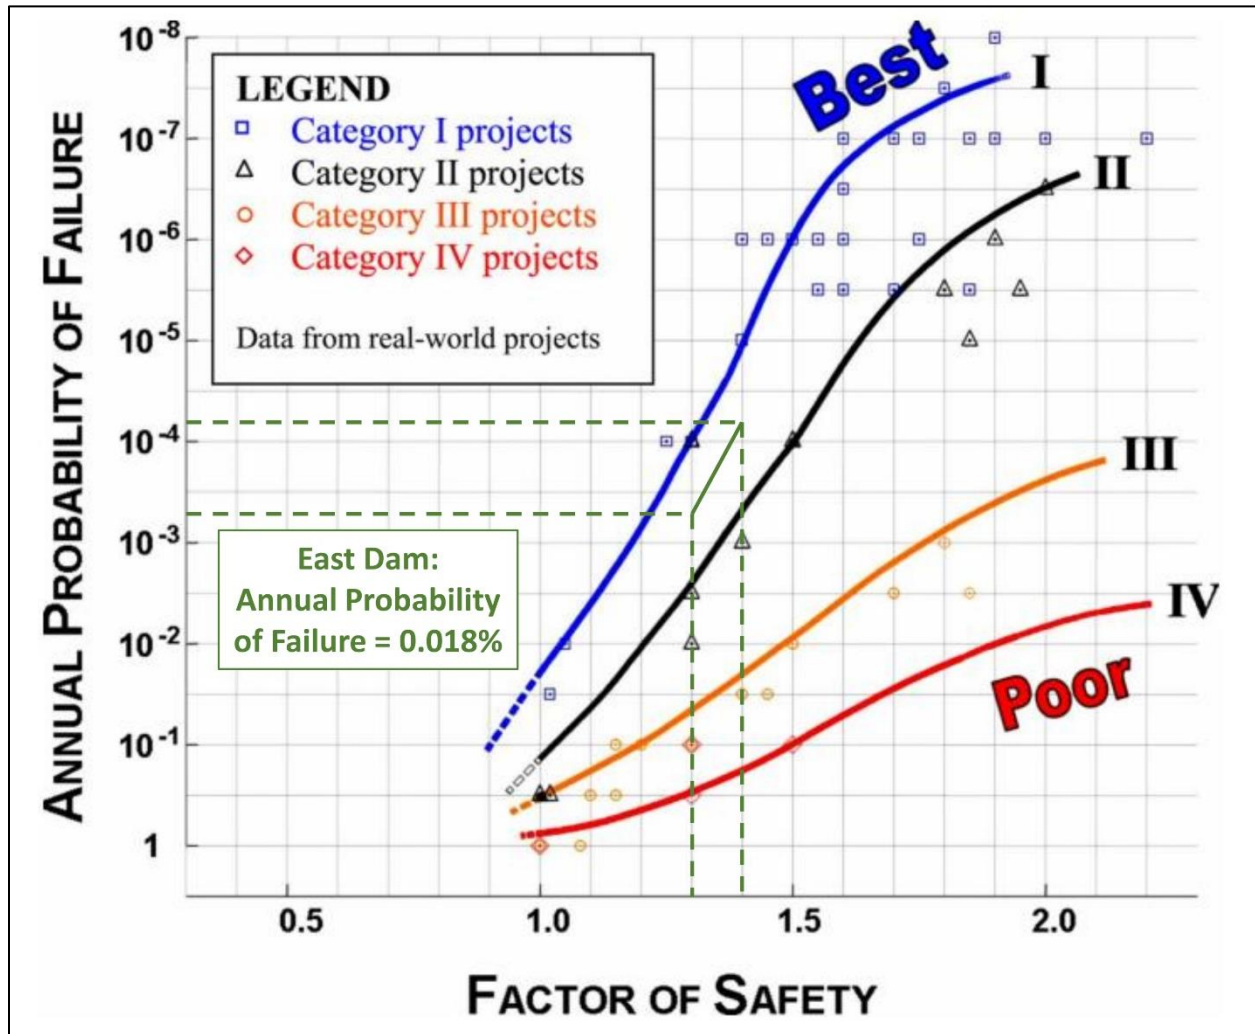
**Figure 39a.** If all engineering from now on were elevated to the highest standards, the Level of Engineering could be increased to 1.5 or midway between Above Average and Best (see Tables 2a-e). The maximum future Level of Engineering is constrained by the characteristics that cannot be fixed, such as the insufficient investigation of the foundation prior to constructing the tailings management facility (see Figs. 19a-b). Assuming the calculated factors of safety of  $FS = 1.3$  and  $FS = 1.4$  would still be valid after improved engineering (see Fig. 26a), the minimum future annual probability of failure of the East Dam was estimated in the range 0.007-0.049% with a best estimate of 0.018%. Based upon the best estimate for the minimum annual probability of failure of the West Dam as 0.002% (see Fig. 39b), the best estimate for the minimum annual probability of failure of the Copper Mountain Tailings Management Facility after improvement of engineering to the highest standards would be 0.02%. Taking into consideration the amount of judgment required in the calculation of the Level of Engineering, the annual probability of failure should be regarded as the range 0.01-0.1% (1 in 10,000 to 1 in 1000). Figure modified from Silva et al. (2008).

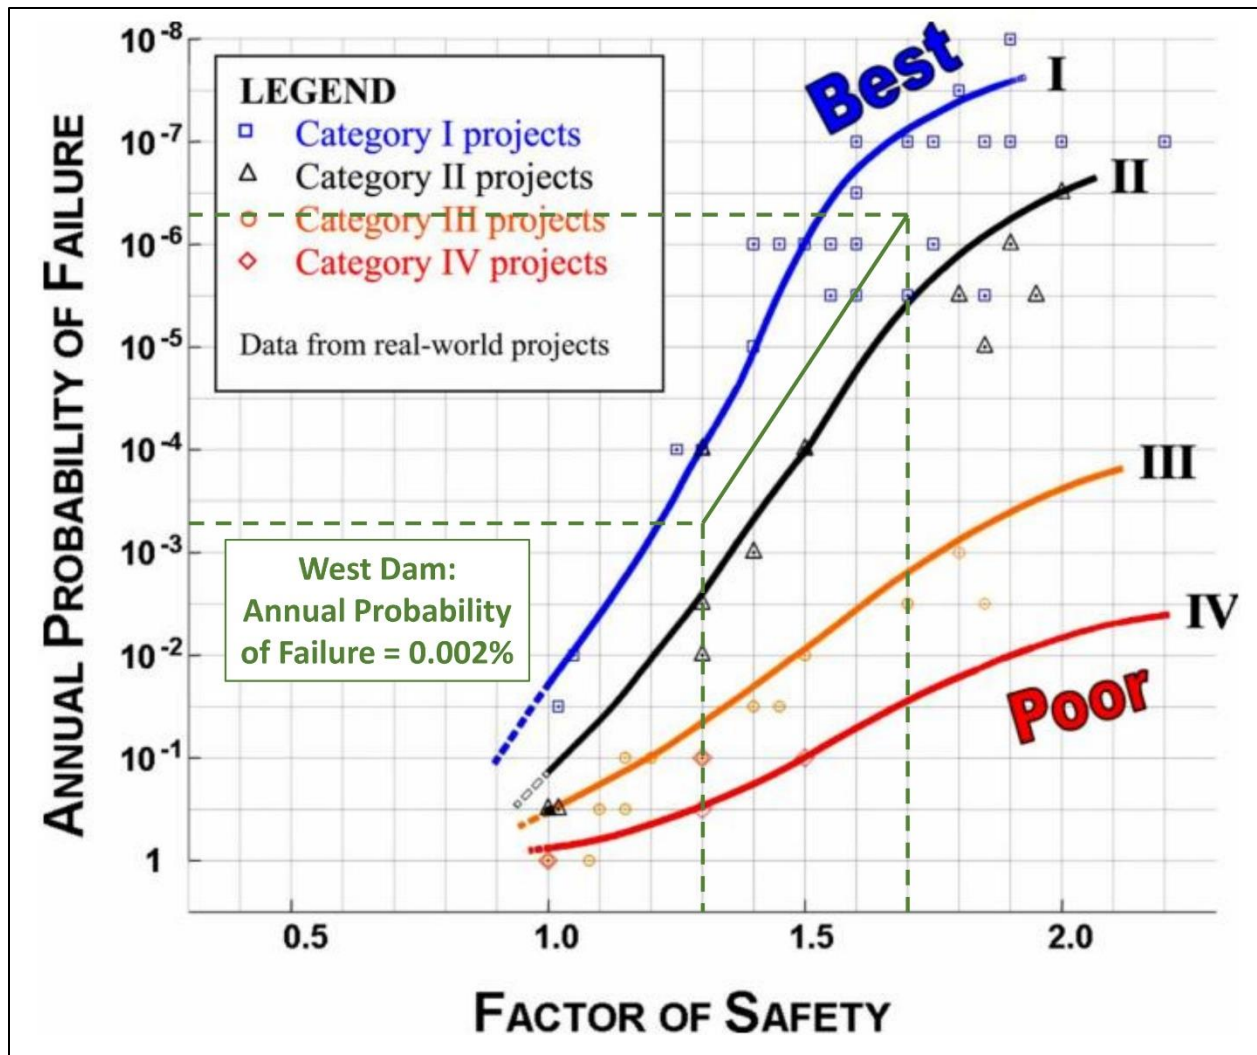
**Figure 39b.** If all engineering from now on were elevated to the highest standards, the Level of Engineering could be increased to 1.5 or midway between Above Average and Best (see Tables 2a-e). The maximum future Level of Engineering is constrained by the characteristics that cannot be fixed, such as the insufficient investigation of the foundation prior to constructing the tailings management facility (see Figs. 19a-b). Assuming the calculated factors of safety of FS = 1.3 and FS = 1.7 would still be valid after improved engineering (see Fig. 26b), the minimum future annual probability of failure of the West Dam was estimated in the range 0.00005-0.007% with a best estimate of 0.002%. Based upon the best estimate for the minimum annual probability of failure of the East Dam as 0.018% (see Fig. 39a), the best estimate for the minimum annual probability of failure of the Copper Mountain Tailings Management Facility after improvement of engineering to the highest standards would be 0.02%. Taking into consideration the amount of judgment required in the calculation of the Level of Engineering, the annual probability of failure should be regarded as the range 0.01-0.1% (1 in 10,000 to 1 in 1000). Figure modified from Silva et al. (2008).
