The Use of the Silva-Lambe-Marr Method for Estimating the Annual Probability of Failure of the Tailings Dams at the Copper Mountain Mine, British Columbia, Canada

Steven H. Emerman, Ph.D., Malach Consulting, LLC, 785 N 200 W, Spanish Fork, Utah 84660, USA, Tel: 1-801-921-1228, E-mail: SHEmerman@gmail.com

Report prepared for Confederated Tribes of the Colville Reservation, submitted July 1, 2022

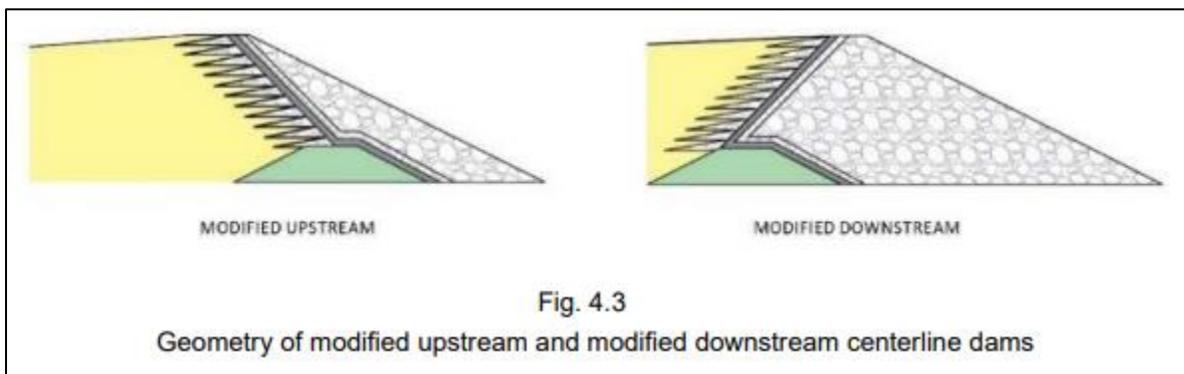
Figure 14. The above diagram from ICOLD (2021) confirms that what has been called the “modified centerline” method (see Fig. 13) should be referred to as the “modified upstream” method. The so-called “modified centerline” method retains the essential characteristics of the upstream method in that successive dikes are constructed on top of uncompacted tailings (compare with Fig. 12a). Figure from ICOLD (2021).

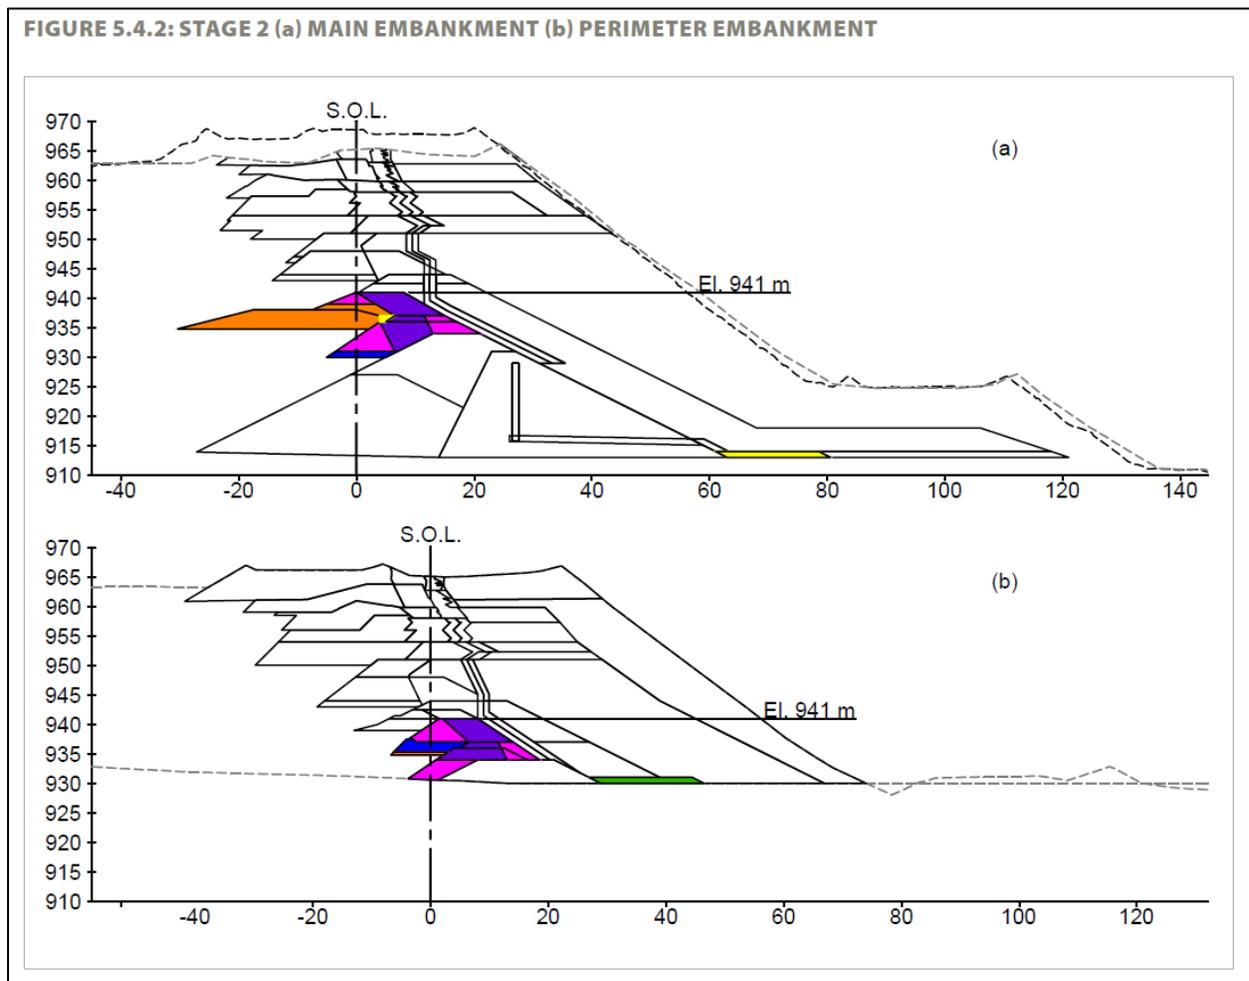
Figure 15a. Although the tailings dam at the Mount Polley mine was designed and permitted as a centerline dam, the Stage 2 dam raise (shown in colors) was constructed using the upstream method. According to Independent Expert Engineering Investigation and Review Panel (2015a), “The as-built configuration of the Stage 2 Main Embankment shown in Figure 5.4.2(a) differed from the design in several important respects ... Rather than adhering to a ‘centreline’ configuration, raise 2 utilized entirely ‘upstream’ construction. The same conditions prevailed for the Perimeter Embankment shown in Figure 5.4.2(b). These as-built conditions were never reconciled with the Stage 2 stability analyses, which had been predicated on the original design configuration.” Although one source (Center for Science in Public Participation (2022)) describes the Mount Polley tailings dam as a modified centerline dam, this is non-standard terminology. The presence of dikes (such as the Stage 2 dam raise) on top of uncompacted tailings should classify the Mount Polley tailings dam as an upstream dam (compare with Figs. 12a, 12c and 14). According to Safety First: Guidelines for Responsible Mine Tailings Management, “A downstream or centerline raise constructed on top of an existing upstream dam or on top of uncompacted tailings still constitutes an upstream dam” (Morrill et al., 2022). Figure from Independent Expert Engineering Investigation and Review Panel (2015a).

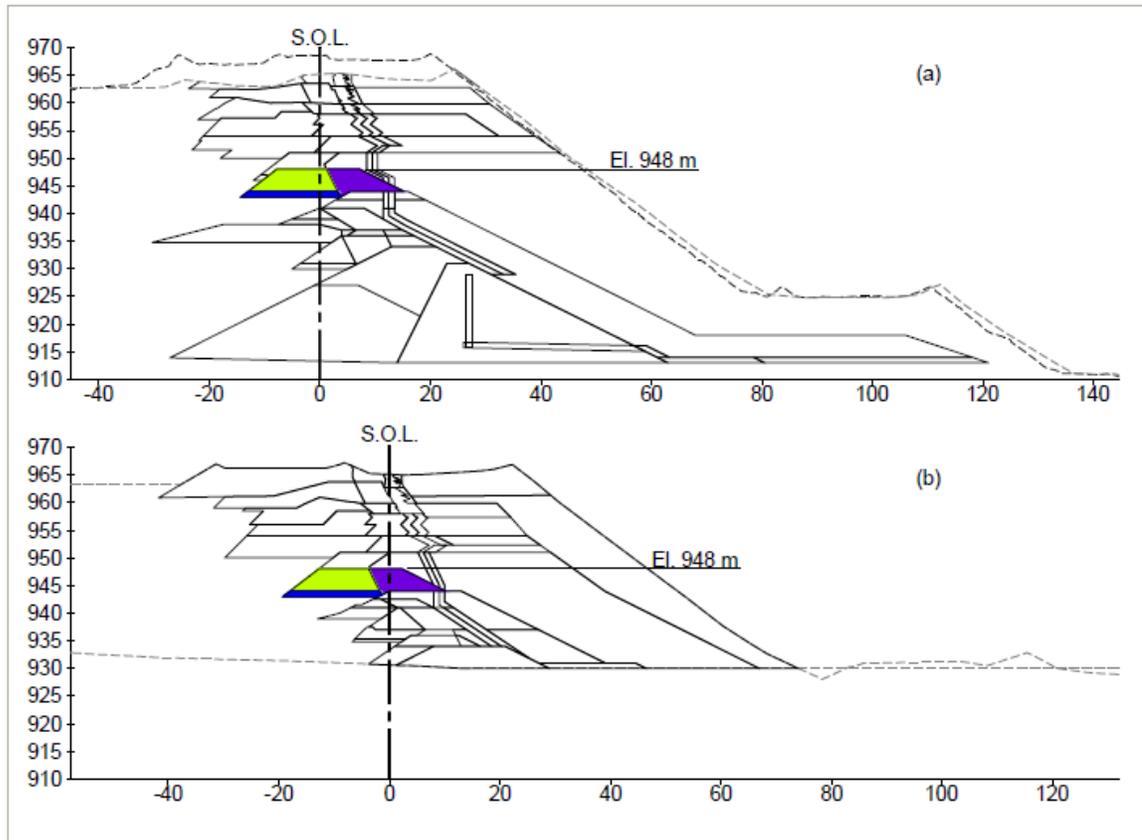
FIGURE 5.4.4: STAGE 4 (a) MAIN EMBANKMENT (b) PERIMETER EMBANKMENT

Figure 15b. Although the tailings dam at the Mount Polley mine was designed and permitted as a centerline dam, the Stage 4 dam raise (shown in colors) was constructed using the upstream method. According to Independent Expert Engineering Investigation and Review Panel (2015a), “As illustrated in Figure 5.4.4, only the cap was constructed in Stage 4 without any additional rockfill on the downstream slope, resulting in another ‘upstream’-type raise.” Although one source (Center for Science in Public Participation (2022)) describes the Mount Polley tailings dam as a modified centerline dam, this is non-standard terminology. The presence of dikes (such as the Stage 4 dam raise) on top of uncompacted tailings should classify the Mount Polley tailings dam as an upstream dam (compare with Figs. 12a, 12c and 14). According to *Safety First: Guidelines for Responsible Mine Tailings Management*, “A downstream or centerline raise constructed on top of an existing upstream dam or on top of uncompacted tailings still constitutes an upstream dam” (Morrill et al., 2022). Figure from Independent Expert Engineering Investigation and Review Panel (2015a).

2 utilized entirely ‘upstream’ construction. The same conditions prevailed for the Perimeter Embankment shown in Figure 5.4.2(b). These as-built conditions were never reconciled with the Stage 2 stability analyses, which had been predicated on the original design configuration ... As illustrated in Figure 5.4.4, only the cap was constructed in Stage 4 without any additional rockfill on the downstream slope, resulting in another ‘upstream’-type raise.” The motivation for the change from centerline to upstream construction was a lack of sufficient waste rock for dam construction, which also motivated the steepening of the dam embankment. According to Independent Expert Engineering Investigation and Review Panel (2015a), “But since the material would now be sourced from mine waste rather than quarried, mine production and delivery had to be accommodated. Due to related restrictions, it was planned to place the Zone C outslope to an ‘interim’ 1.4H:1V inclination—rather than the design basis 2.0H:1V—as a temporary expedient until mine waste delivery could catch up with construction. The steeper slope would be expanded and flattened to 2.0H:1V ‘once the embankments have reached the Stage 5 design elevation’ ... Stage 5 construction proceeded from Stage 4 in a continuous, uninterrupted campaign and was completed in November 2007. But instead of rectifying the interim steep slopes at this time as had been intended, such measures were left to future stages of embankment raising.”

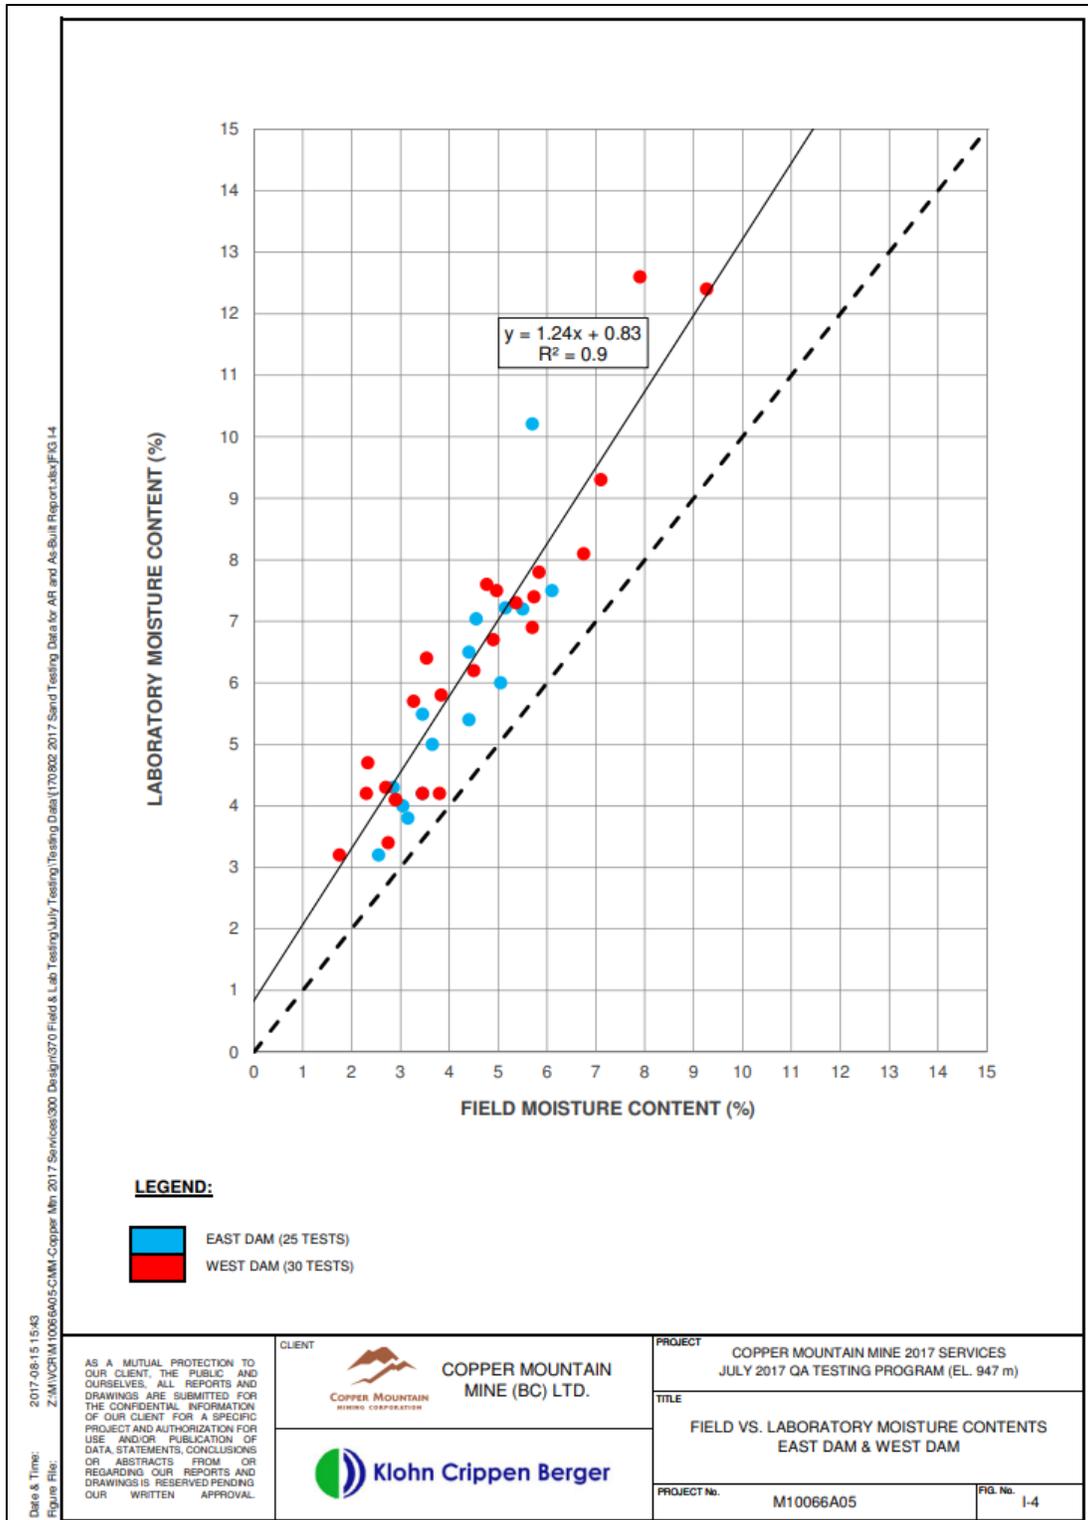
Figure 21. For the recent dam raises (since 2015), there has been an excellent correlation between moisture content measured in the field and lab. This generally fulfills the requirement of “Evaluate differences between laboratory test conditions and field conditions” for the category Above Average in the area Design – Testing for Level of Engineering. However, there is no such documentation for the construction prior to 2015. The category for Level of Engineering in the area of Design – Testing was chosen as Average to Above Average (see Table 1b). Figure from Klohn Crippen Berger (2018).

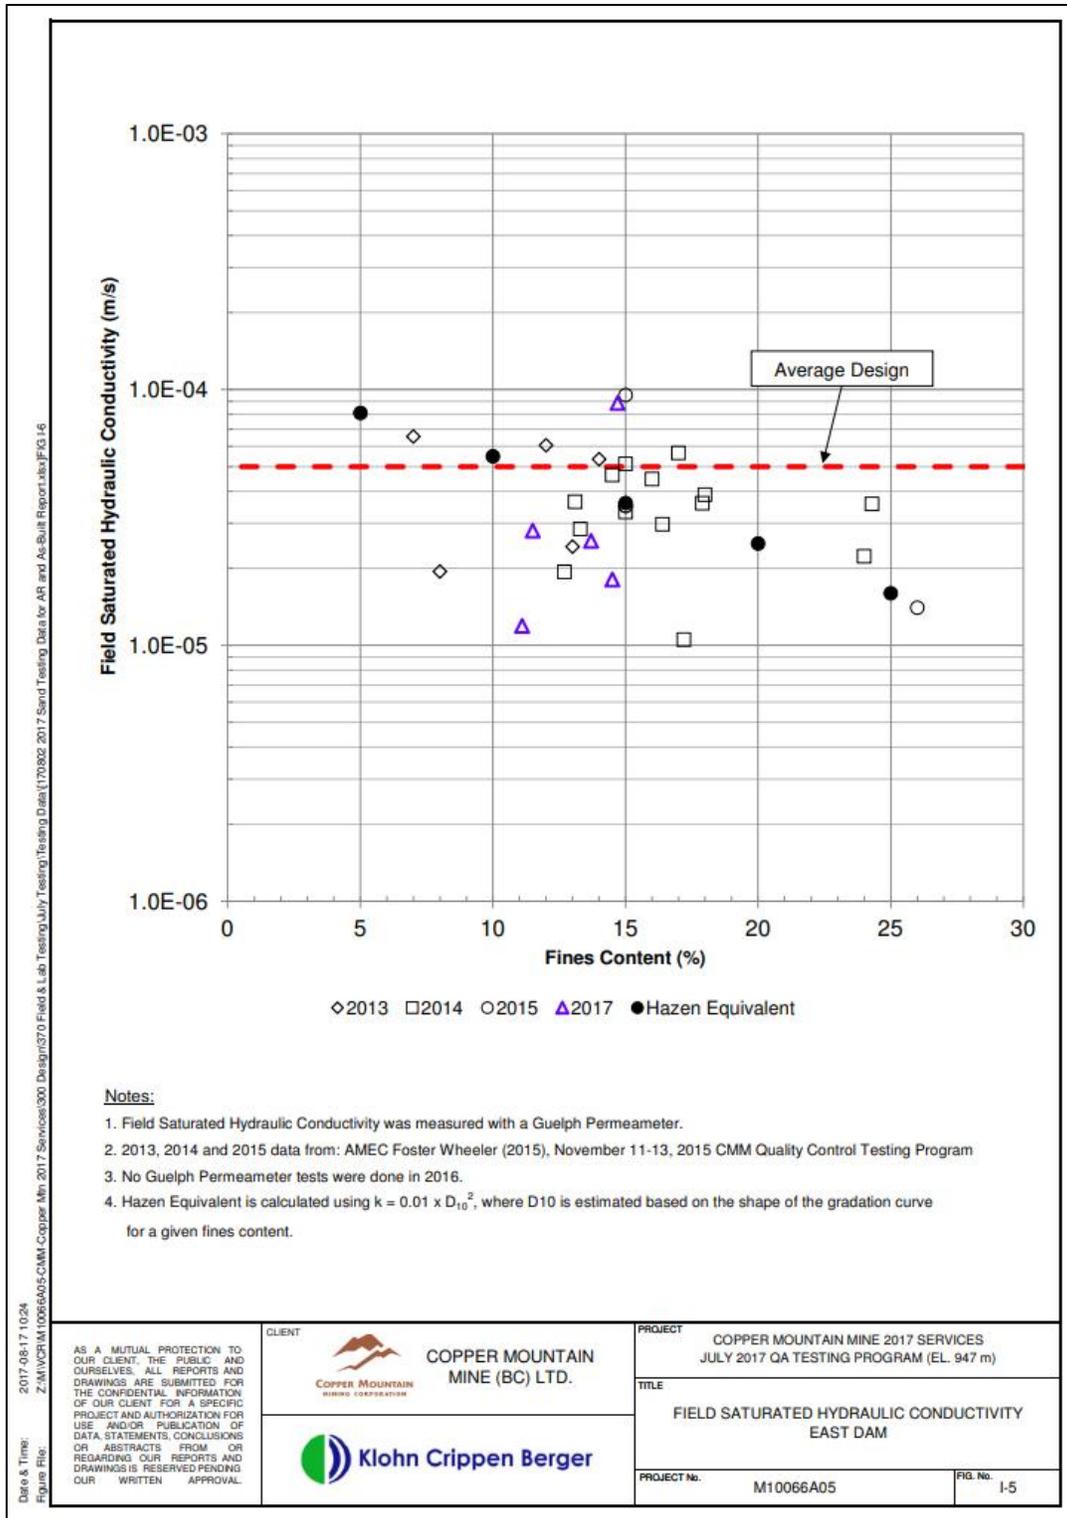
Figure 22. For the recent dam raises (since 2015), field saturated hydraulic conductivity (see Fig. 20c) was compared with the fines content. This generally fulfills the requirement of “Evaluate differences between laboratory test conditions and field conditions” for the category Above Average in the area Design – Testing for Level of Engineering. However, there is no such documentation for the construction prior to 2015. The category for Level of Engineering in the area of Design – Testing was chosen as Average to Above Average (see Table 1b). Figure from Klohn Crippen Berger (2018).

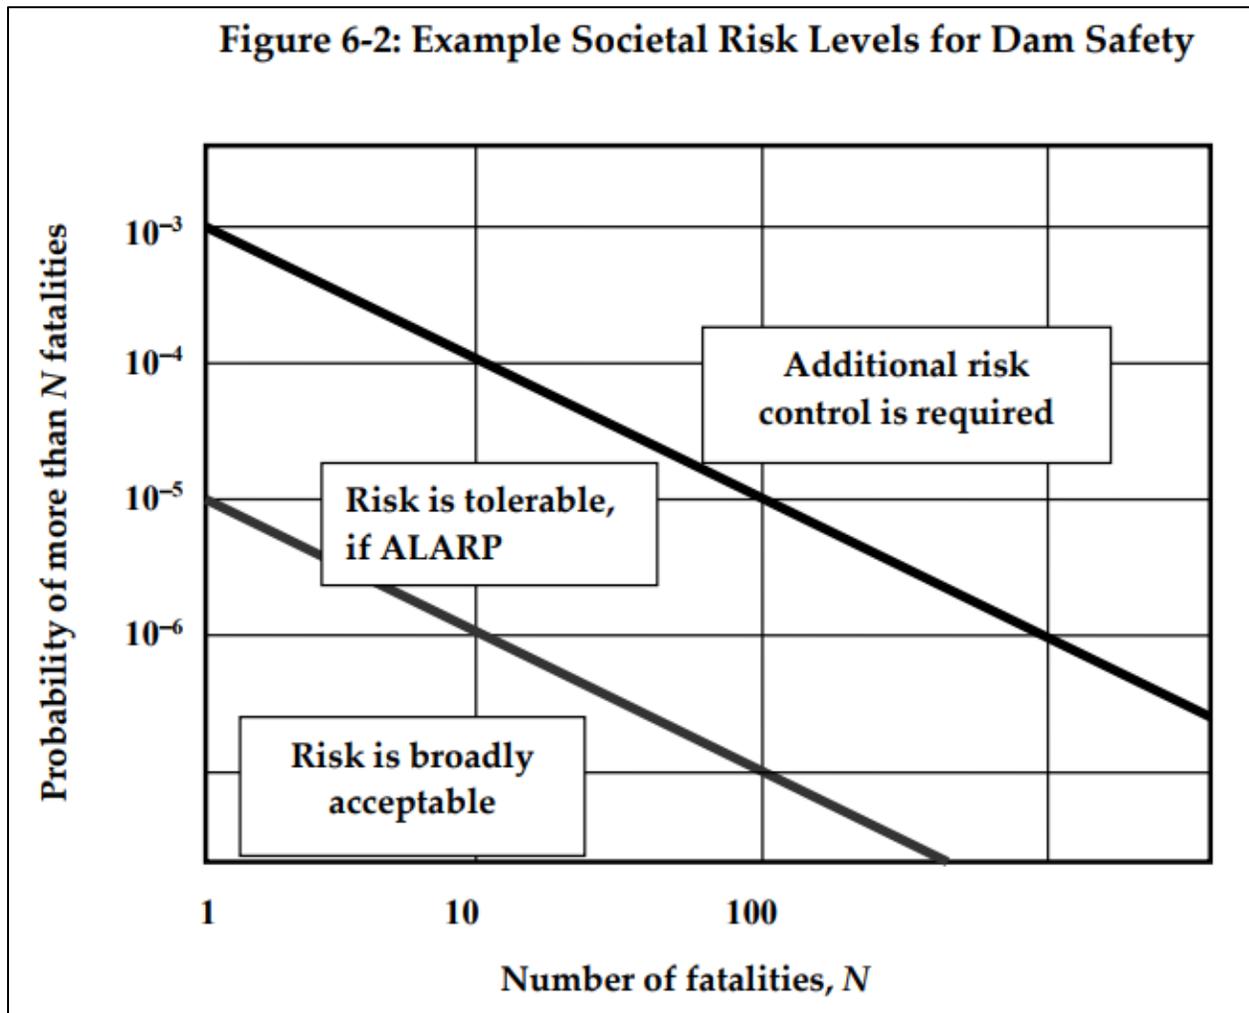
Figure 35a. According to the guidelines of the Canadian Dam Association, an annual probability of dam failure of 0.1% (1 in 1000) is marginally acceptable (outside of the region “Additional risk control is required”) only if dam failure would result in no more than one potential fatality, and broad acceptability would require an annual probability of failure no greater than 0.001% (1 in 100,000). The dam failure consequence category of the tailings dams at the Copper Mountain mine is Extreme, meaning that failure would result in the potential loss of more than 100 lives. For the minimum of 100 fatalities, marginal acceptability would require annual probability of dam failure no greater than 0.001% (1 in 100,000), while broad acceptability would require annual probability of dam failure no greater than 0.00001% (1 in 10,000,000). On the above basis, an annual probability of failure of the Copper Mountain Tailings Management Facility in the range 0.1-1% (1 in 1000 to 1 in 100) is entirely unacceptable. The region “Risk is tolerable, if ALARP” indicates that the risk is acceptable only after all measures have been carried out to bring the annual probability of failure As Low as Reasonably Practicable (ALARP). According to Canadian Dam Association (2013), “The ALARP principle is based on the duty to reduce risks to life to the point where further risk reduction is impracticable or requires action that is grossly disproportionate in time, trouble, and effort to the reduction of risk achieved.” Figure from Canadian Dam Association (2013).

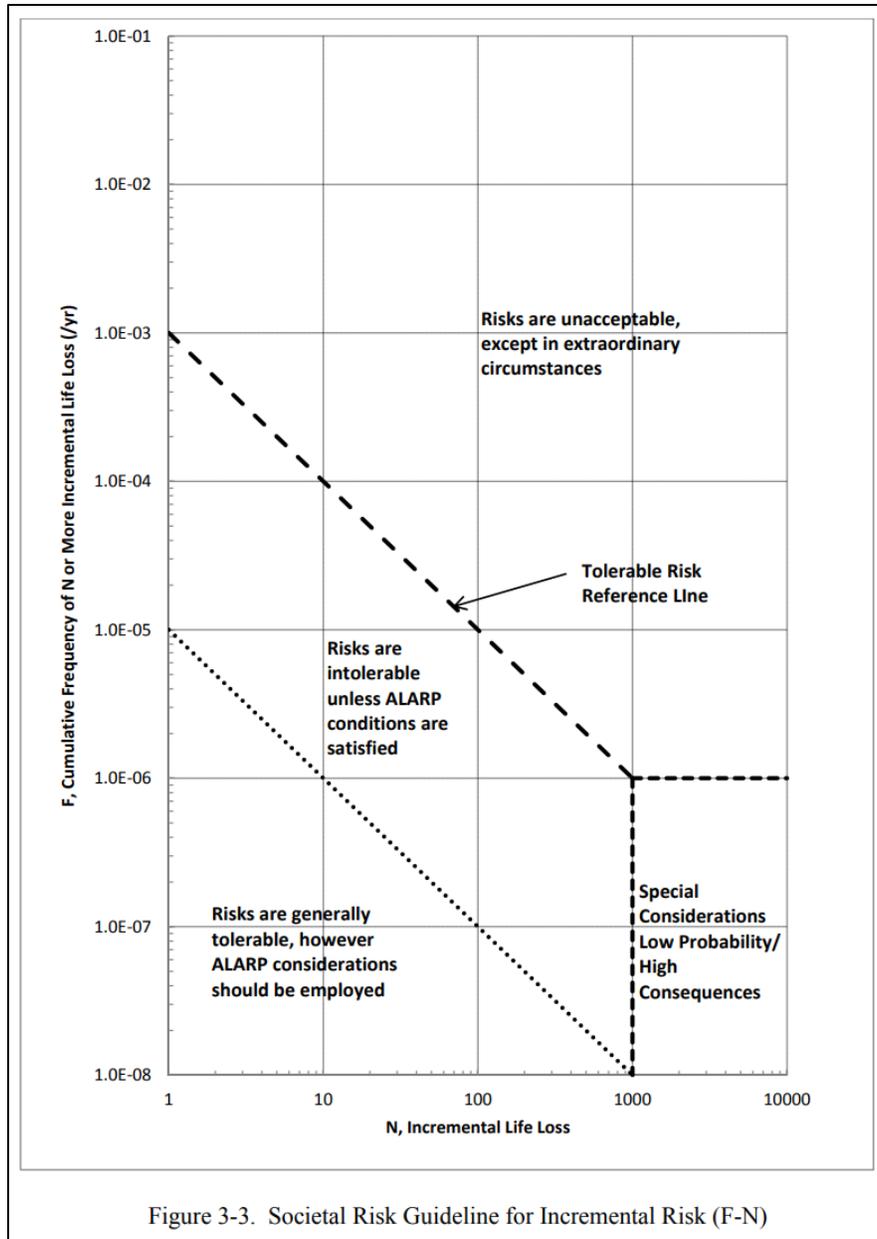
Figure 35b. According to the societal risk guidelines of the (USA) Federal Energy Regulatory Commission, an annual probability of dam failure of 0.1% (1 in 1000) is at the Tolerable Risk Reference Line (outside of the region “Risks are unacceptable, except in extraordinary circumstances”) only if dam failure would result in no more than one potential fatality, and the region “Risks are generally tolerable” would require an annual probability of failure no greater than 0.001% (1 in 100,000). The dam failure consequence category of the tailings dams at the Copper Mountain mine is Extreme, meaning that failure would result in the potential loss of more than 100 lives. For the minimum of 100 fatalities, the Tolerable Risk Reference Line would require annual probability of dam failure no greater than 0.001% (1 in 100,000), while the region “Risks are generally tolerable” would require annual probability of dam failure no greater than 0.00001% (1 in 10,000,000). On the above basis, an annual probability of failure of the Copper Mountain Tailings Management Facility in the range 0.1-1% (1 in 1000 to 1 in 100) is entirely unacceptable. The region “Risk is intolerable, unless ALARP conditions are satisfied” indicates that the risk is tolerable only after all measures have been carried out to bring the annual probability of failure As Low as Reasonably Practicable (ALARP). According to FERC (2016), “The application of ALARP considerations mean that actions should be taken to reduce risk below the tolerable risk reference line until such actions are impracticable or not cost effective.” Figure from FERC (2016).

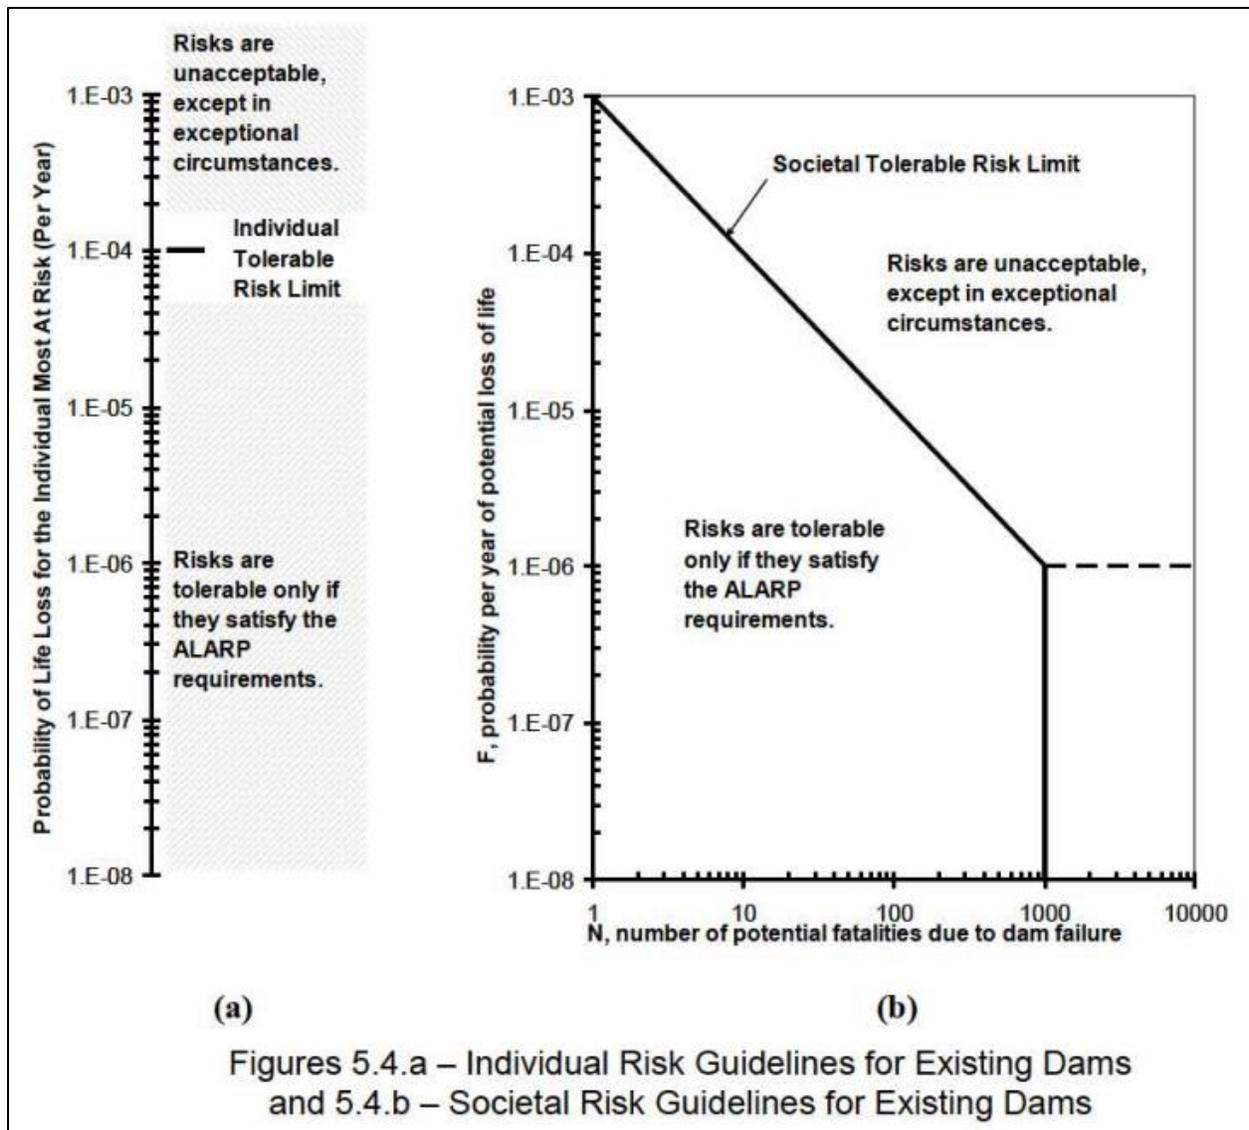
Figure 35c. According to the societal risk guidelines of the U.S. Army Corps of Engineers for existing dams, an annual probability of dam failure of 0.1% (1 in 1000) is at the Societal Tolerable Risk Limit (outside of the region “Risks are unacceptable, except in extraordinary circumstances”) only if dam failure would result in no more than one potential fatality. The dam failure consequence category of the tailings dams at the Copper Mountain mine is Extreme, meaning that failure would result in the potential loss of more than 100 lives. For the minimum of 100 fatalities, the Societal Tolerable Risk Limit would require annual probability of dam failure no greater than 0.001% (1 in 100,000). On the above basis, an annual probability of failure of the Copper Mountain Tailings Management Facility in the range 0.1-1% (1 in 1000 to 1 in 100) is entirely unacceptable. The region “Risks are tolerable only if they satisfy ALARP requirements” indicates that the risk is tolerable only after all measures have been carried out to bring the annual probability of failure As Low as Reasonably Practicable (ALARP). According to USACE (2014), “The application of ALARP considerations mean that actions should be taken to reduce risk below the tolerable risk limit until such actions are impracticable or not cost effective.” Figure from USACE (2014).

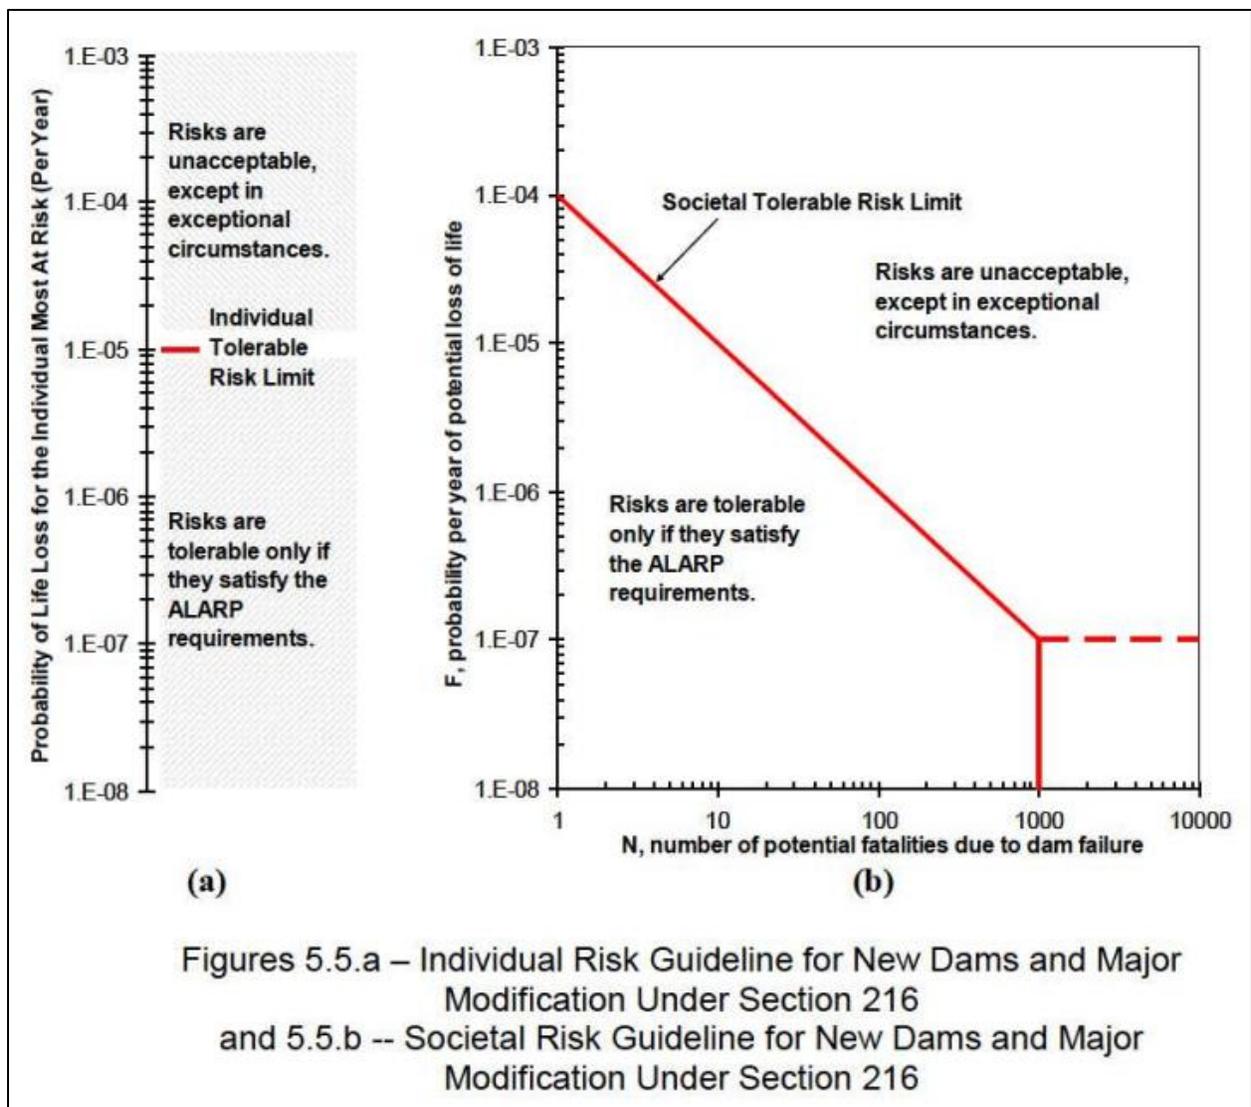
Figure 35d. According to the societal risk guidelines of the U.S. Army Corps of Engineers for new dams and major modifications, an annual probability of dam failure of 0.01% (1 in 10,000) is at the Societal Tolerable Risk Limit (outside of the region “Risks are unacceptable, except in extraordinary circumstances”) only if dam failure would result in no more than one potential fatality. The dam failure consequence category of the tailings dams at the Copper Mountain mine is Extreme, meaning that failure would result in the potential loss of more than 100 lives. For the minimum of 100 fatalities, the Societal Tolerable Risk Limit would require annual probability of dam failure no greater than 0.0001% (1 in 1,000,000). On the above basis, an annual probability of failure of the Copper Mountain Tailings Management Facility in the range 0.1-1% (1 in 1000 to 1 in 100) is entirely unacceptable. The region “Risks are tolerable only if they satisfy ALARP requirements” indicates that the risk is tolerable only after all measures have been carried out to bring the annual probability of failure As Low as Reasonably Practicable (ALARP). According to USACE (2014), “The application of ALARP considerations mean that actions should be taken to reduce risk below the tolerable risk limit until such actions are impracticable or not cost effective.” Figure from USACE (2014).

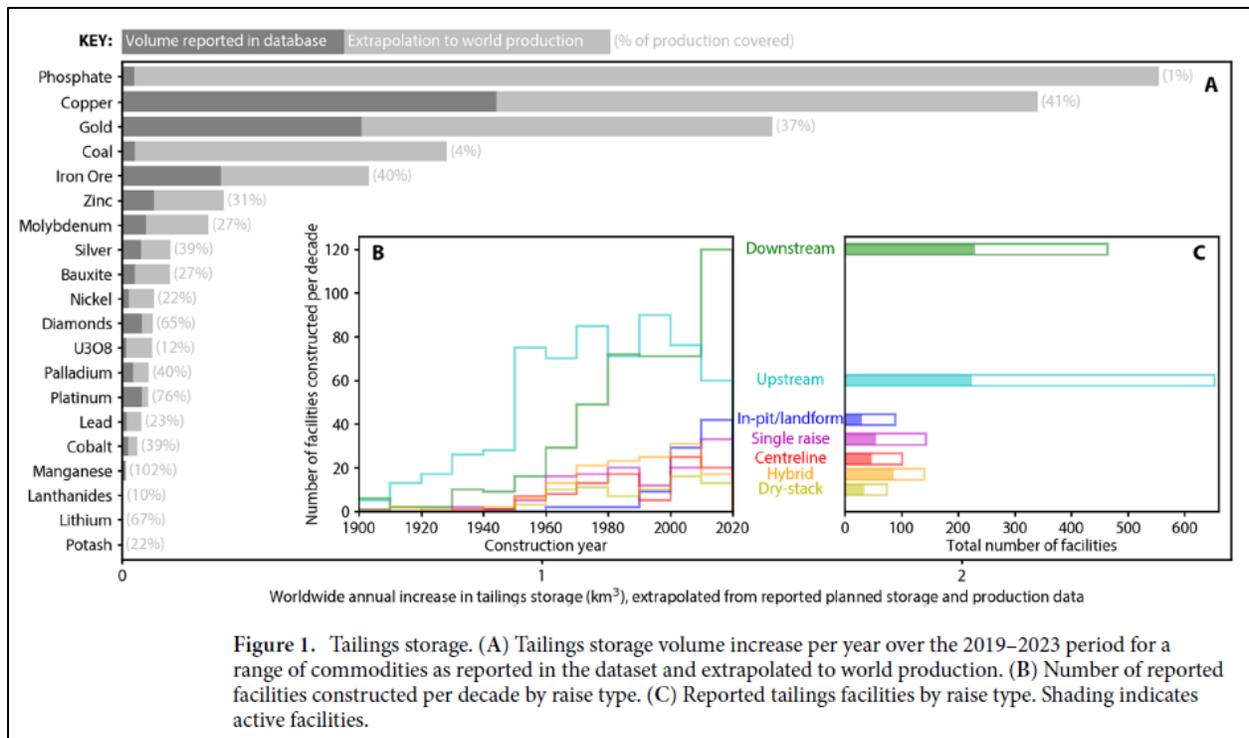
Figure 36. According to Franks et al. (2021), “while upstream facilities make up 37 per cent of the total, they have declined from a peak of 85 per cent of new facilities in 1920–1929 to 19 per cent of new facilities in 2010–2019 (Fig. 1B).” In addition, upstream facilities made up 45%, 41%, and 32% of total new facilities for the decades 1960–1969, 1970–1979, and 1980–1989, respectively, indicating that it was generally known by the 1970s that the benefits of upstream construction did not outweigh the risks. Figure from Franks et al. (2021).

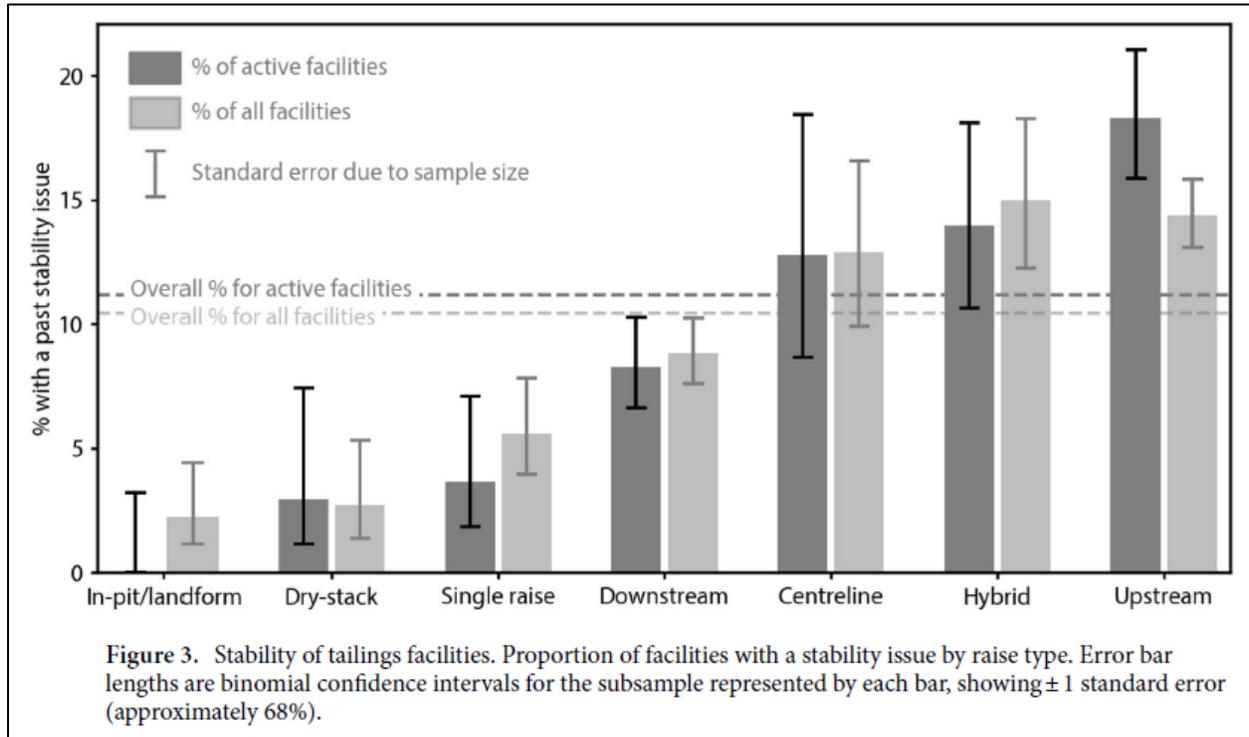
Figure 37. According to Franks et al. (2021), “Our findings reveal that in practice active upstream facilities report a higher incidence of stability issues (18.3%) than other facility types, and that this elevated risk persists even when these facilities are built in high governance settings ... The likelihood of a stability issue in active upstream facilities is twice that of active downstream facilities ... The control tests [age, height, volume, seismic hazard, wind speed, and rainfall] showed that the properties of the upstream samples (notably their distribution of age), have a small effect on the incidence of stability, however the estimated effect is only about one standard error, and is not sufficient to account for their higher than average incidence.” The stability issue was an answer to the particular question “Has this facility, at any point in its history, failed to be confirmed or certified as stable, or experienced notable stability concerns, as identified by an independent engineer (even if later certified as stable by the same or a different firm)?” with the clarification “We note that this will depend on factors including local legislation that are not necessarily tied to best practice. As such, and because remedial action may have been taken, a ‘Yes’ answer may not indicate heightened risk. Stability concerns might include toe seepage, dam movement, overtopping, spillway failure, piping etc. If yes, have appropriately designed and reviewed mitigation actions been implemented? We also note that this question does not bear upon the appropriateness of the criteria, but rather the stewardship levels of the facility or the dam” (Franks et al., 2021). Figure from Franks et al. (2021).

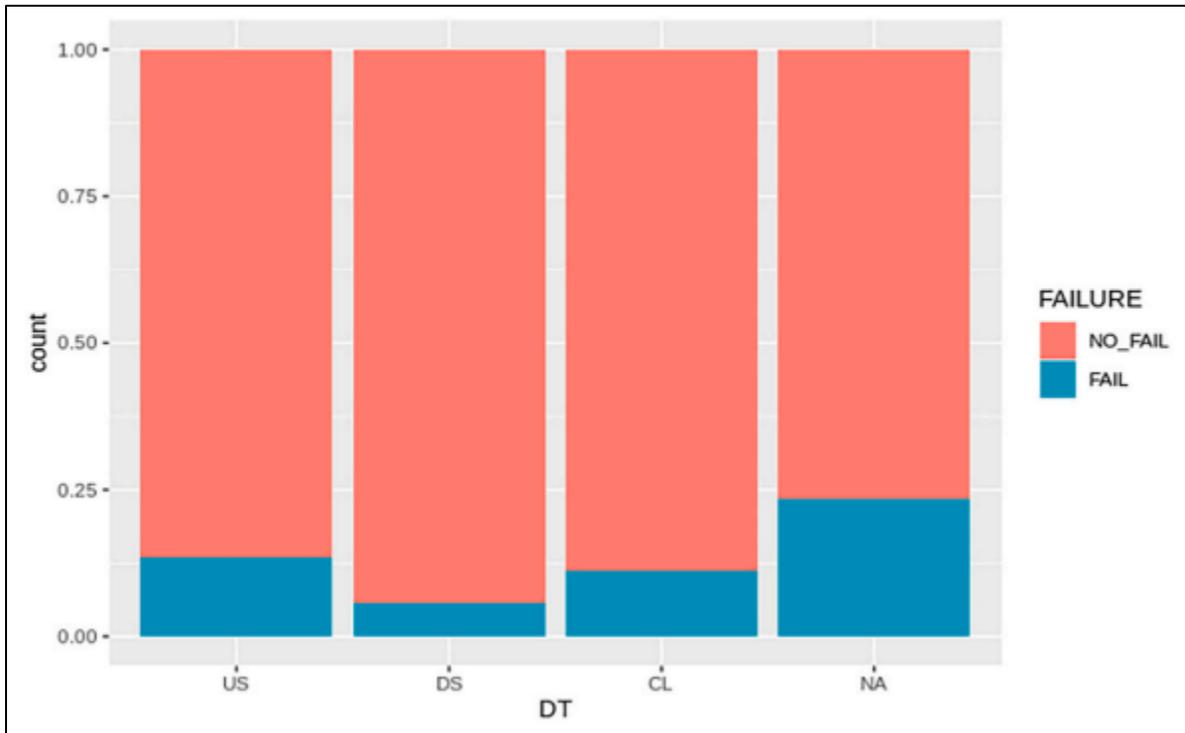
Figure 38. By comparing datasets on global tailings dam failures (Center for Science in Public Participation, 2022) with global tailings dams (Franks et al., 2021; GRID-Arendal, 2022), Piciullo et al. (2022) showed a disproportionately large representation of upstream tailings dams among tailings dam failures. DT = Dam Type, US = Upstream, DS = Downstream, CL = Centerline. Figure from Piciullo et al. (2022).

In addition to greater stability issues, Piciullo et al. (2022) have documented the disproportionately large representation of upstream tailings dams among tailings dam failures (see Fig. 38). According to Piciullo et al. (2022), “Joining the databases on failures and existing dams, the fraction of failures as a function of the dam construction method has been computed ... we observe that for a relatively high fraction of the incidents in the failure database the construction method was not known ... For the tailings dam failures with a documented construction method, a higher frequency (relative to total number of dams in the catalogue of

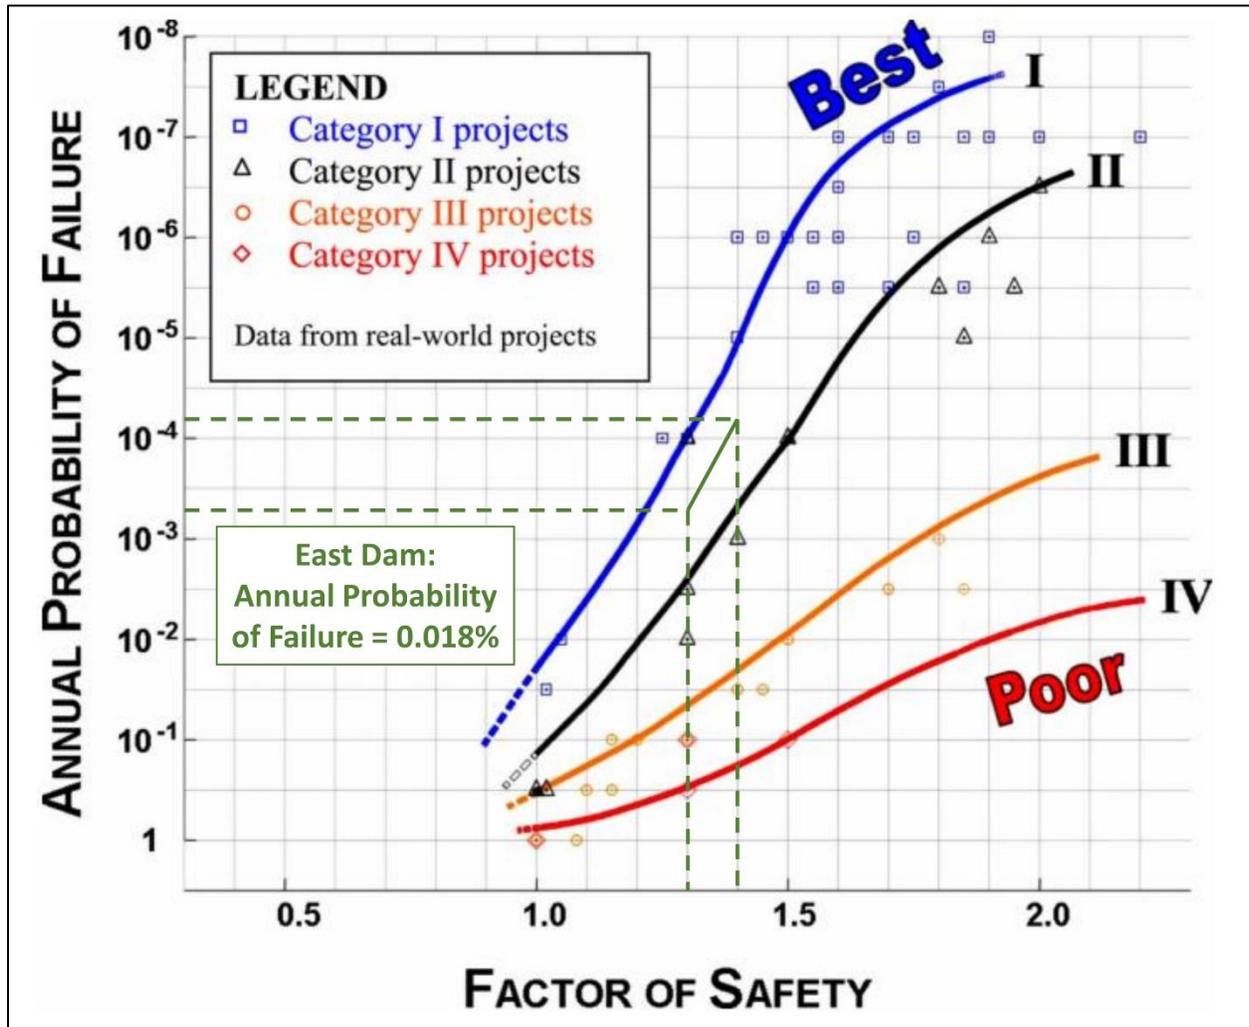
Figure 39a. If all engineering from now on were elevated to the highest standards, the Level of Engineering could be increased to 1.5 or midway between Above Average and Best (see Tables 2a-e). The maximum future Level of Engineering is constrained by the characteristics that cannot be fixed, such as the insufficient investigation of the foundation prior to constructing the tailings management facility (see Figs. 19a-b). Assuming the calculated factors of safety of $FS = 1.3$ and $FS = 1.4$ would still be valid after improved engineering (see Fig. 26a), the minimum future annual probability of failure of the East Dam was estimated in the range 0.007-0.049% with a best estimate of 0.018%. Based upon the best estimate for the minimum annual probability of failure of the West Dam as 0.002% (see Fig. 39b), the best estimate for the minimum annual probability of failure of the Copper Mountain Tailings Management Facility after improvement of engineering to the highest standards would be 0.02%. Taking into consideration the amount of judgment required in the calculation of the Level of Engineering, the annual probability of failure should be regarded as the range 0.01-0.1% (1 in 10,000 to 1 in 1000). Figure modified from Silva et al. (2008).

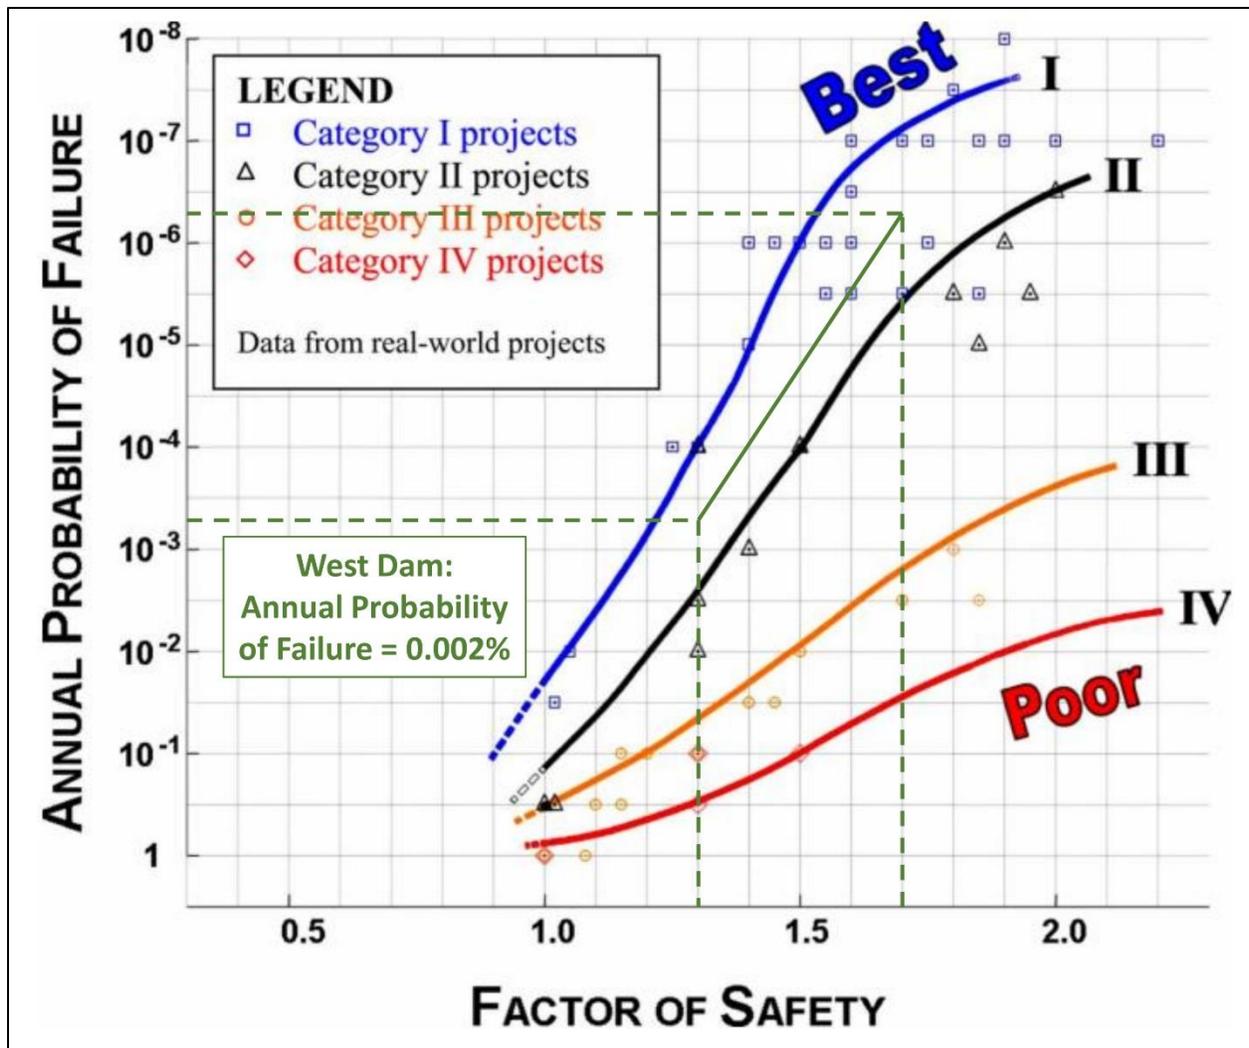
future annual probability of failure of the West Dam was estimated in the range 0.00005-0.007% with a best estimate of 0.002% (see Fig. 39b).

Figure 39b. If all engineering from now on were elevated to the highest standards, the Level of Engineering could be increased to 1.5 or midway between Above Average and Best (see Tables 2a-e). The maximum future Level of Engineering is constrained by the characteristics that cannot be fixed, such as the insufficient investigation of the foundation prior to constructing the tailings management facility (see Figs. 19a-b). Assuming the calculated factors of safety of FS = 1.3 and FS = 1.7 would still be valid after improved engineering (see Fig. 26b), the minimum future annual probability of failure of the West Dam was estimated in the range 0.00005-0.007% with a best estimate of 0.002%. Based upon the best estimate for the minimum annual probability of failure of the East Dam as 0.018% (see Fig. 39a), the best estimate for the minimum annual probability of failure of the Copper Mountain Tailings Management Facility after improvement of engineering to the highest standards would be 0.02%. Taking into consideration the amount of judgment required in the calculation of the Level of Engineering, the annual probability of failure should be regarded as the range 0.01-0.1% (1 in 10,000 to 1 in 1000). Figure modified from Silva et al. (2008).
