# **The Use of the Silva-Lambe-Marr Method for Estimating the Annual Probability of Failure of the Tailings Dams at the Copper Mountain Mine, British Columbia, Canada**

Steven H. Emerman, Ph.D., Malach Consulting, LLC, 785 N 200 W, Spanish Fork, Utah 84660, USA, Tel: 1-801-921-1228, E-mail: SHEmerman@gmail.com

Report prepared for Confederated Tribes of the Colville Reservation, submitted July 1, 2022

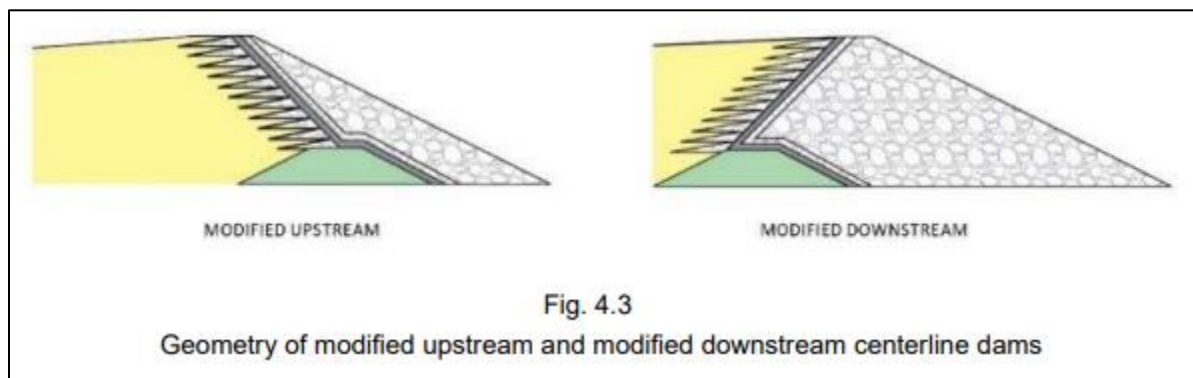
**Figure 14.** The above diagram from ICOLD (2021) confirms that what has been called the “modified centerline” method (see Fig. 13) should be referred to as the “modified upstream” method. The so-called “modified centerline” method retains the essential characteristics of the upstream method in that successive dikes are constructed on top of uncompacted tailings (compare with Fig. 12a). Figure from ICOLD (2021).

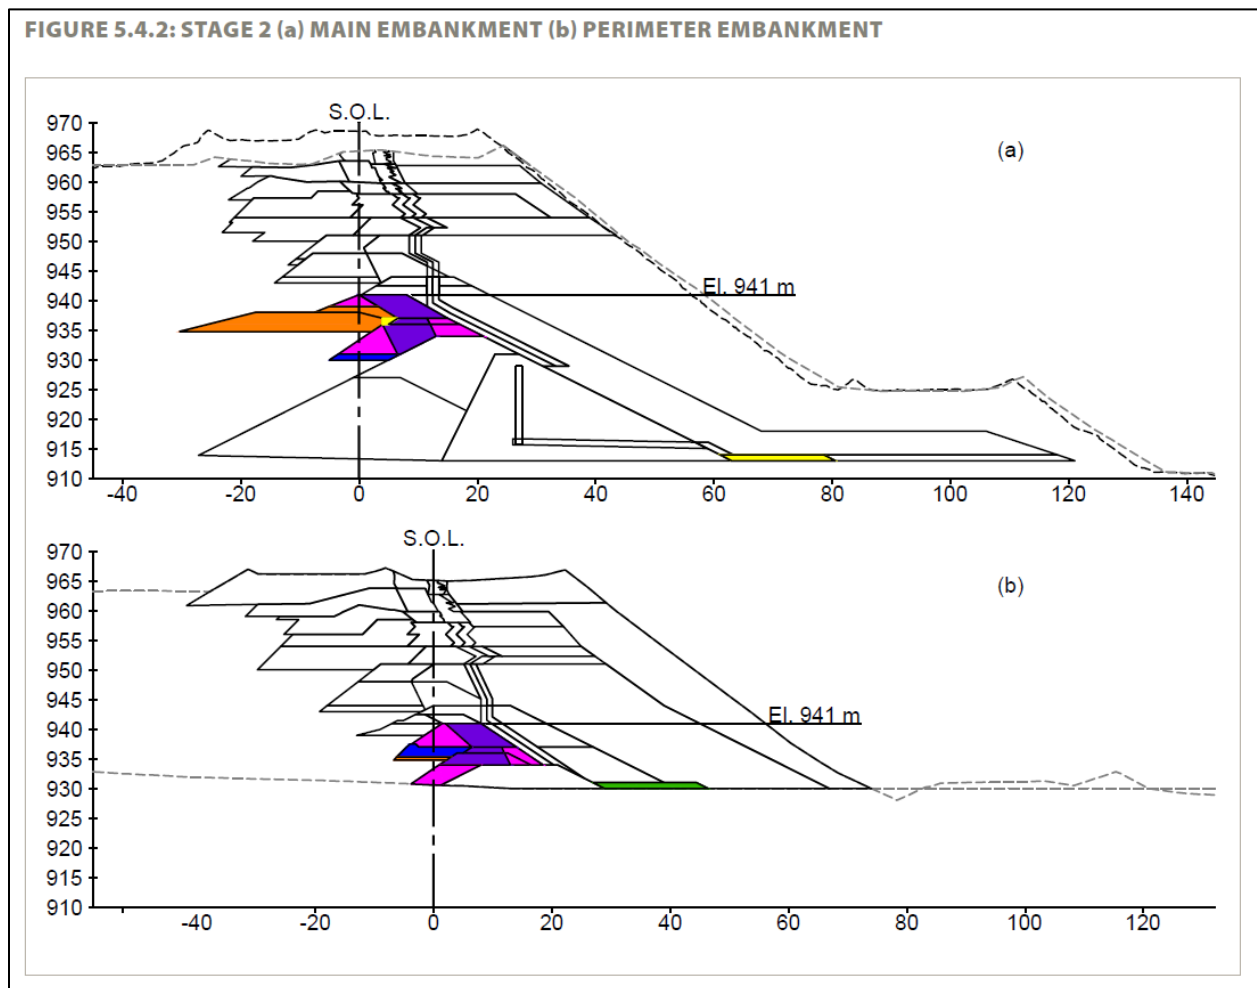
**Figure 15a.** Although the tailings dam at the Mount Polley mine was designed and permitted as a centerline dam, the Stage 2 dam raise (shown in colors) was constructed using the upstream method. According to Independent Expert Engineering Investigation and Review Panel (2015a), “The as-built configuration of the Stage 2 Main Embankment shown in Figure 5.4.2(a) differed from the design in several important respects ... Rather than adhering to a ‘centreline’ configuration, raise 2 utilized entirely ‘upstream’ construction. The same conditions prevailed for the Perimeter Embankment shown in Figure 5.4.2(b). These as-built conditions were never reconciled with the Stage 2 stability analyses, which had been predicated on the original design configuration.” Although one source (Center for Science in Public Participation (2022)) describes the Mount Polley tailings dam as a modified centerline dam, this is non-standard terminology. The presence of dikes (such as the Stage 2 dam raise) on top of uncompacted tailings should classify the Mount Polley tailings dam as an upstream dam (compare with Figs. 12a, 12c and 14). According to Safety First: Guidelines for Responsible Mine Tailings Management, “A downstream or centerline raise constructed on top of an existing upstream dam or on top of uncompacted tailings still constitutes an upstream dam” (Morrill et al., 2022). Figure from Independent Expert Engineering Investigation and Review Panel (2015a).

For this report, a particularly relevant example of a hybrid dam that should be regarded as an upstream dam is the tailings dam at the Mount Polley mine in British Columbia, which failed in August 2014 with a release of 24 million cubic meters of tailings. The permit for the tailings dam called for the use of the centerline method. However, the Stage 2 and Stage 4 raises for the tailings dam used the upstream method, placing the new dam construction material directly on top of the uncompacted tailings, in violation of the permit (see Figs. 15a-b). According to Independent Expert Engineering Investigation and Review Panel (2015a), “The as-built configuration of the Stage 2 Main Embankment shown in Figure 5.4.2(a) differed from the design in several important respects ... Rather than adhering to a ‘centreline’ configuration, raise

2 utilized entirely ‘upstream’ construction. The same conditions prevailed for the Perimeter Embankment shown in Figure 5.4.2(b). These as-built conditions were never reconciled with the Stage 2 stability analyses, which had been predicated on the original design configuration ... As illustrated in Figure 5.4.4, only the cap was constructed in Stage 4 without any additional rockfill on the downstream slope, resulting in another ‘upstream’-type raise.” The motivation for the change from centerline to upstream construction was a lack of sufficient waste rock for dam construction, which also motivated the steepening of the dam embankment. According to Independent Expert Engineering Investigation and Review Panel (2015a), “But since the material would now be sourced from mine waste rather than quarried, mine production and delivery had to be accommodated. Due to related restrictions, it was planned to place the Zone C outslope to an ‘interim’ 1.4H:1V inclination—rather than the design basis 2.0H:1V—as a temporary expedient until mine waste delivery could catch up with construction. The steeper slope would be expanded and flattened to 2.0H:1V ‘once the embankments have reached the Stage 5 design elevation’ ... Stage 5 construction proceeded from Stage 4 in a continuous, uninterrupted campaign and was completed in November 2007. But instead of rectifying the interim steep slopes at this time as had been intended, such measures were left to future stages of embankment raising.”

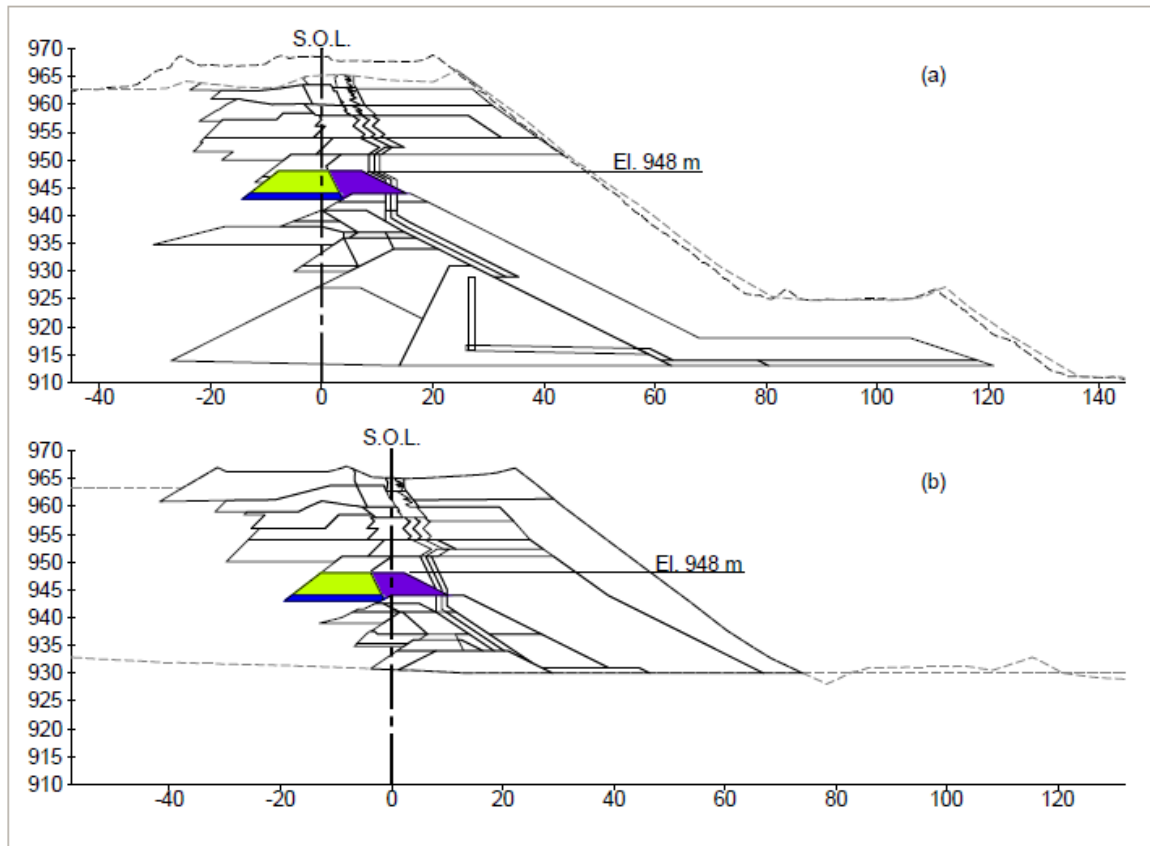
FIGURE 5.4.4: STAGE 4 (a) MAIN EMBANKMENT (b) PERIMETER EMBANKMENT

**Figure 15b.** Although the tailings dam at the Mount Polley mine was designed and permitted as a centerline dam, the Stage 4 dam raise (shown in colors) was constructed using the upstream method. According to Independent Expert Engineering Investigation and Review Panel (2015a), “As illustrated in Figure 5.4.4, only the cap was constructed in Stage 4 without any additional rockfill on the downstream slope, resulting in another ‘upstream’-type raise.” Although one source (Center for Science in Public Participation (2022)) describes the Mount Polley tailings dam as a modified centerline dam, this is non-standard terminology. The presence of dikes (such as the Stage 4 dam raise) on top of uncompacted tailings should classify the Mount Polley tailings dam as an upstream dam (compare with Figs. 12a, 12c and 14). According to *Safety First: Guidelines for Responsible Mine Tailings Management*, “A downstream or centerline raise constructed on top of an existing upstream dam or on top of uncompacted tailings still constitutes an upstream dam” (Morrill et al., 2022). Figure from Independent Expert Engineering Investigation and Review Panel (2015a).

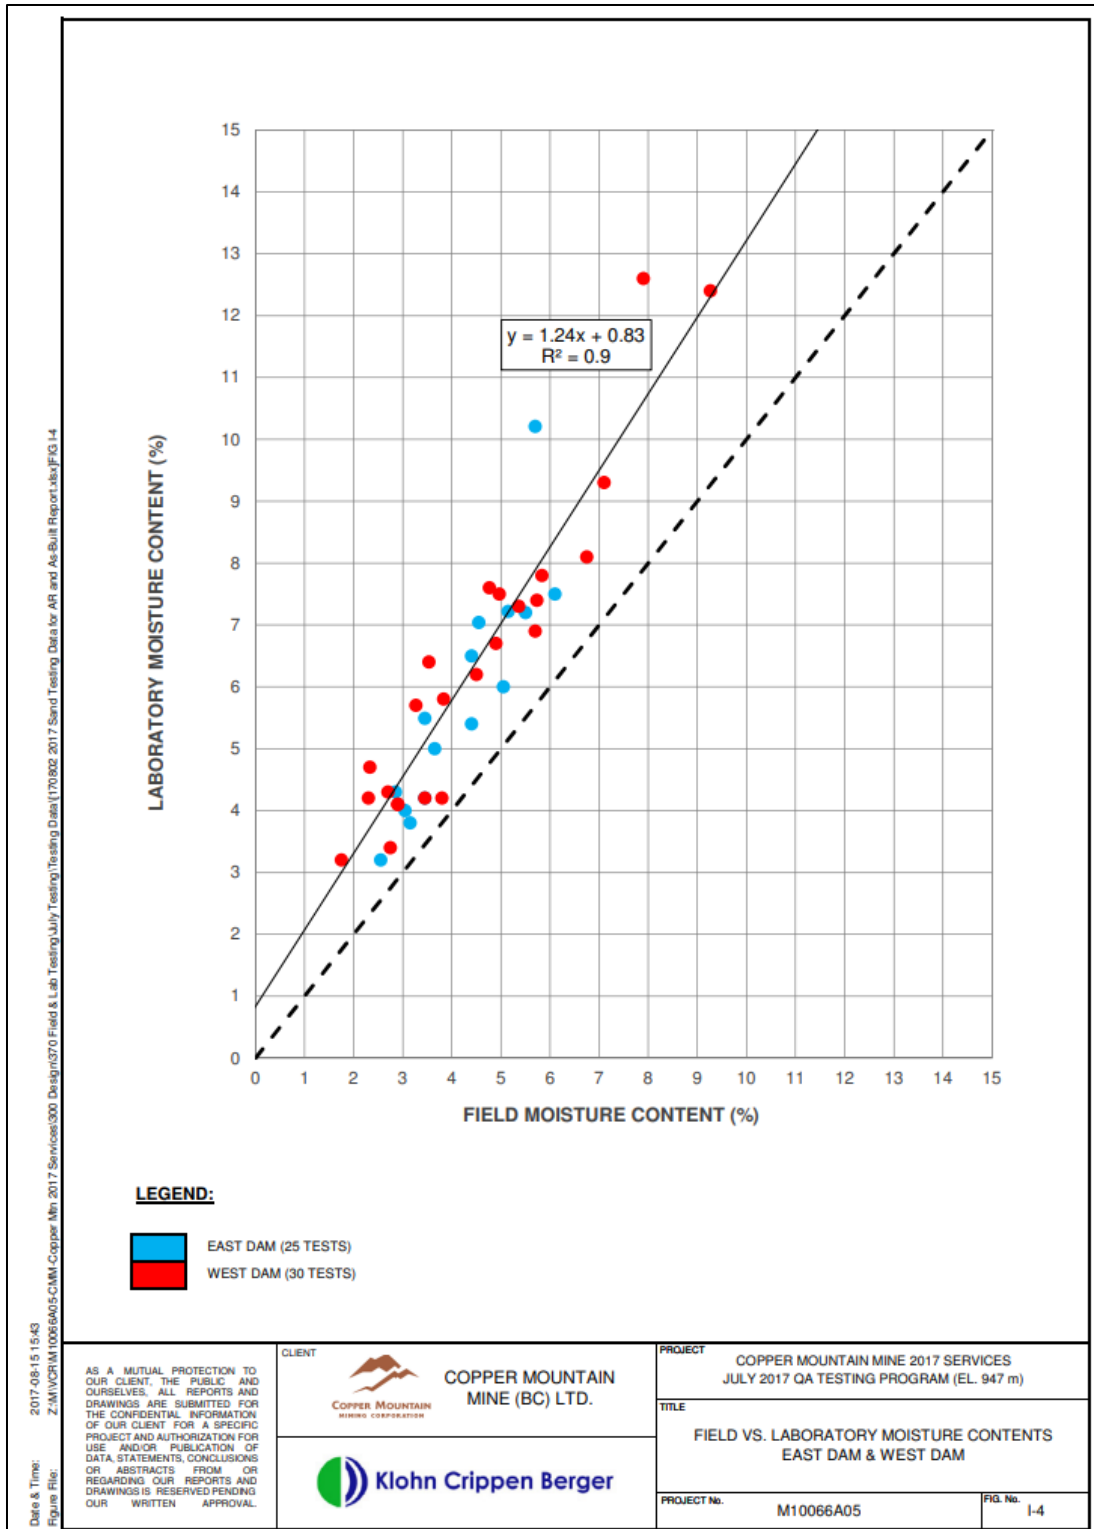
**Figure 21.** For the recent dam raises (since 2015), there has been an excellent correlation between moisture content measured in the field and lab. This generally fulfills the requirement of “Evaluate differences between laboratory test conditions and field conditions” for the category Above Average in the area Design – Testing for Level of Engineering. However, there is no such documentation for the construction prior to 2015. The category for Level of Engineering in the area of Design – Testing was chosen as Average to Above Average (see Table 1b). Figure from Klohn Crippen Berger (2018).

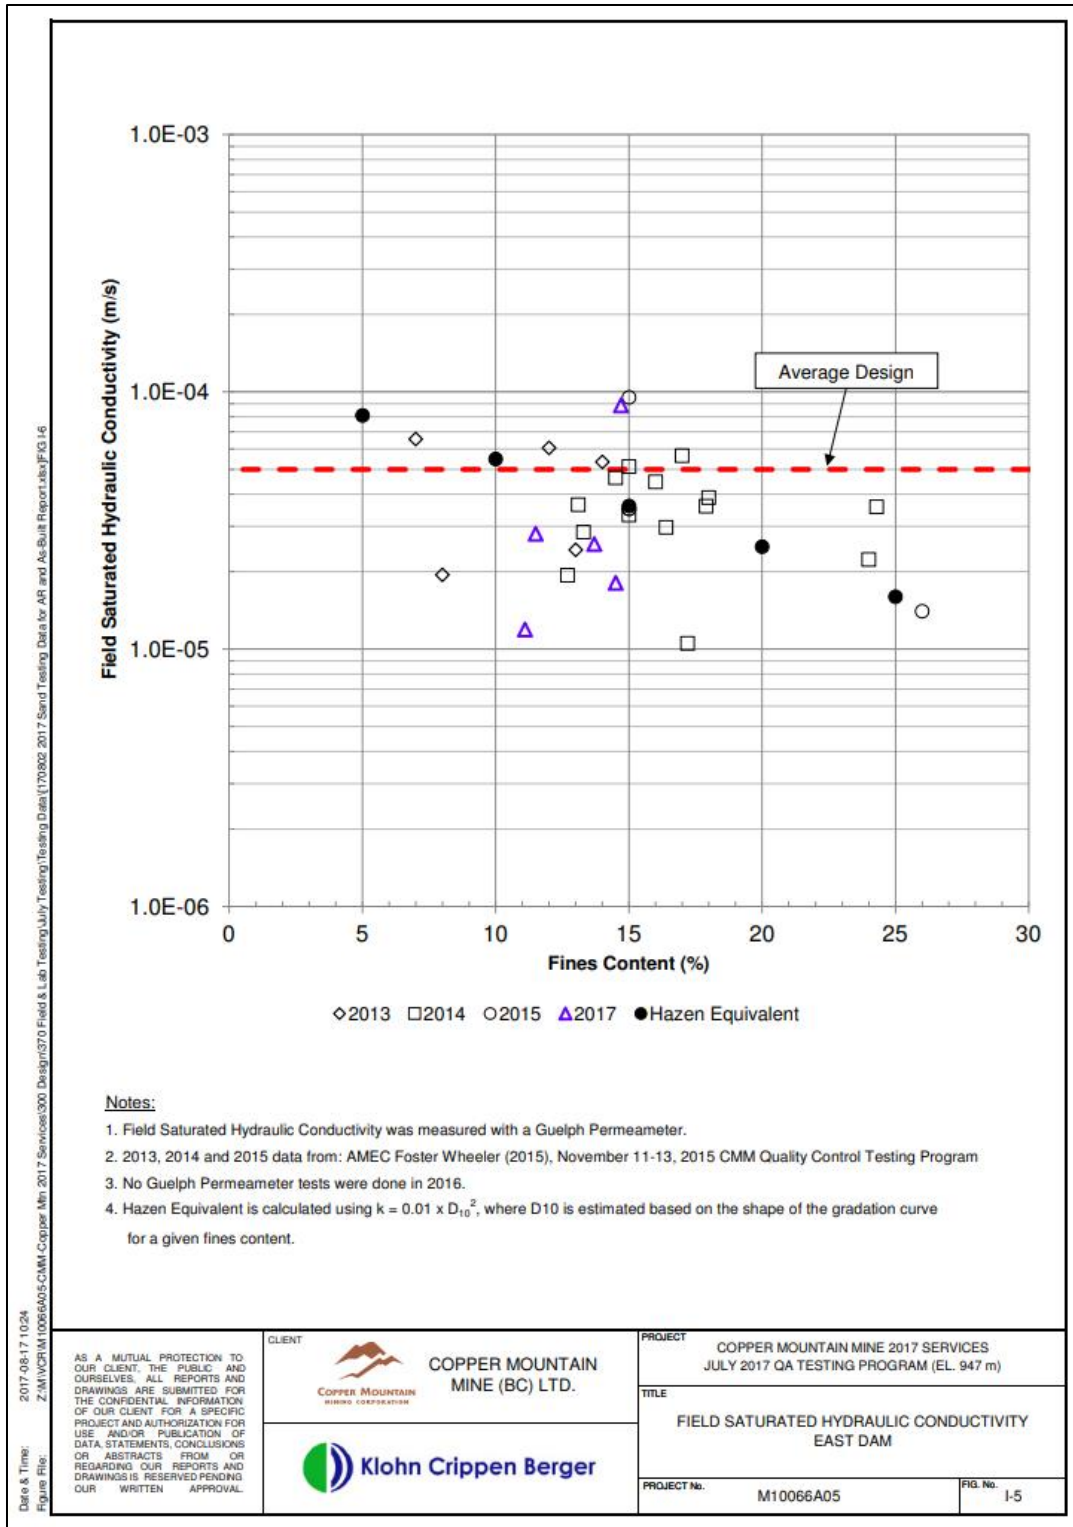
**Figure 22.** For the recent dam raises (since 2015), field saturated hydraulic conductivity (see Fig. 20c) was compared with the fines content. This generally fulfills the requirement of “Evaluate differences between laboratory test conditions and field conditions” for the category Above Average in the area Design – Testing for Level of Engineering. However, there is no such documentation for the construction prior to 2015. The category for Level of Engineering in the area of Design – Testing was chosen as Average to Above Average (see Table 1b). Figure from Klohn Crippen Berger (2018).
